SAUDI GLOBAL PORTS

## Other type of damages

## CONTAINER DAMAGE CODES

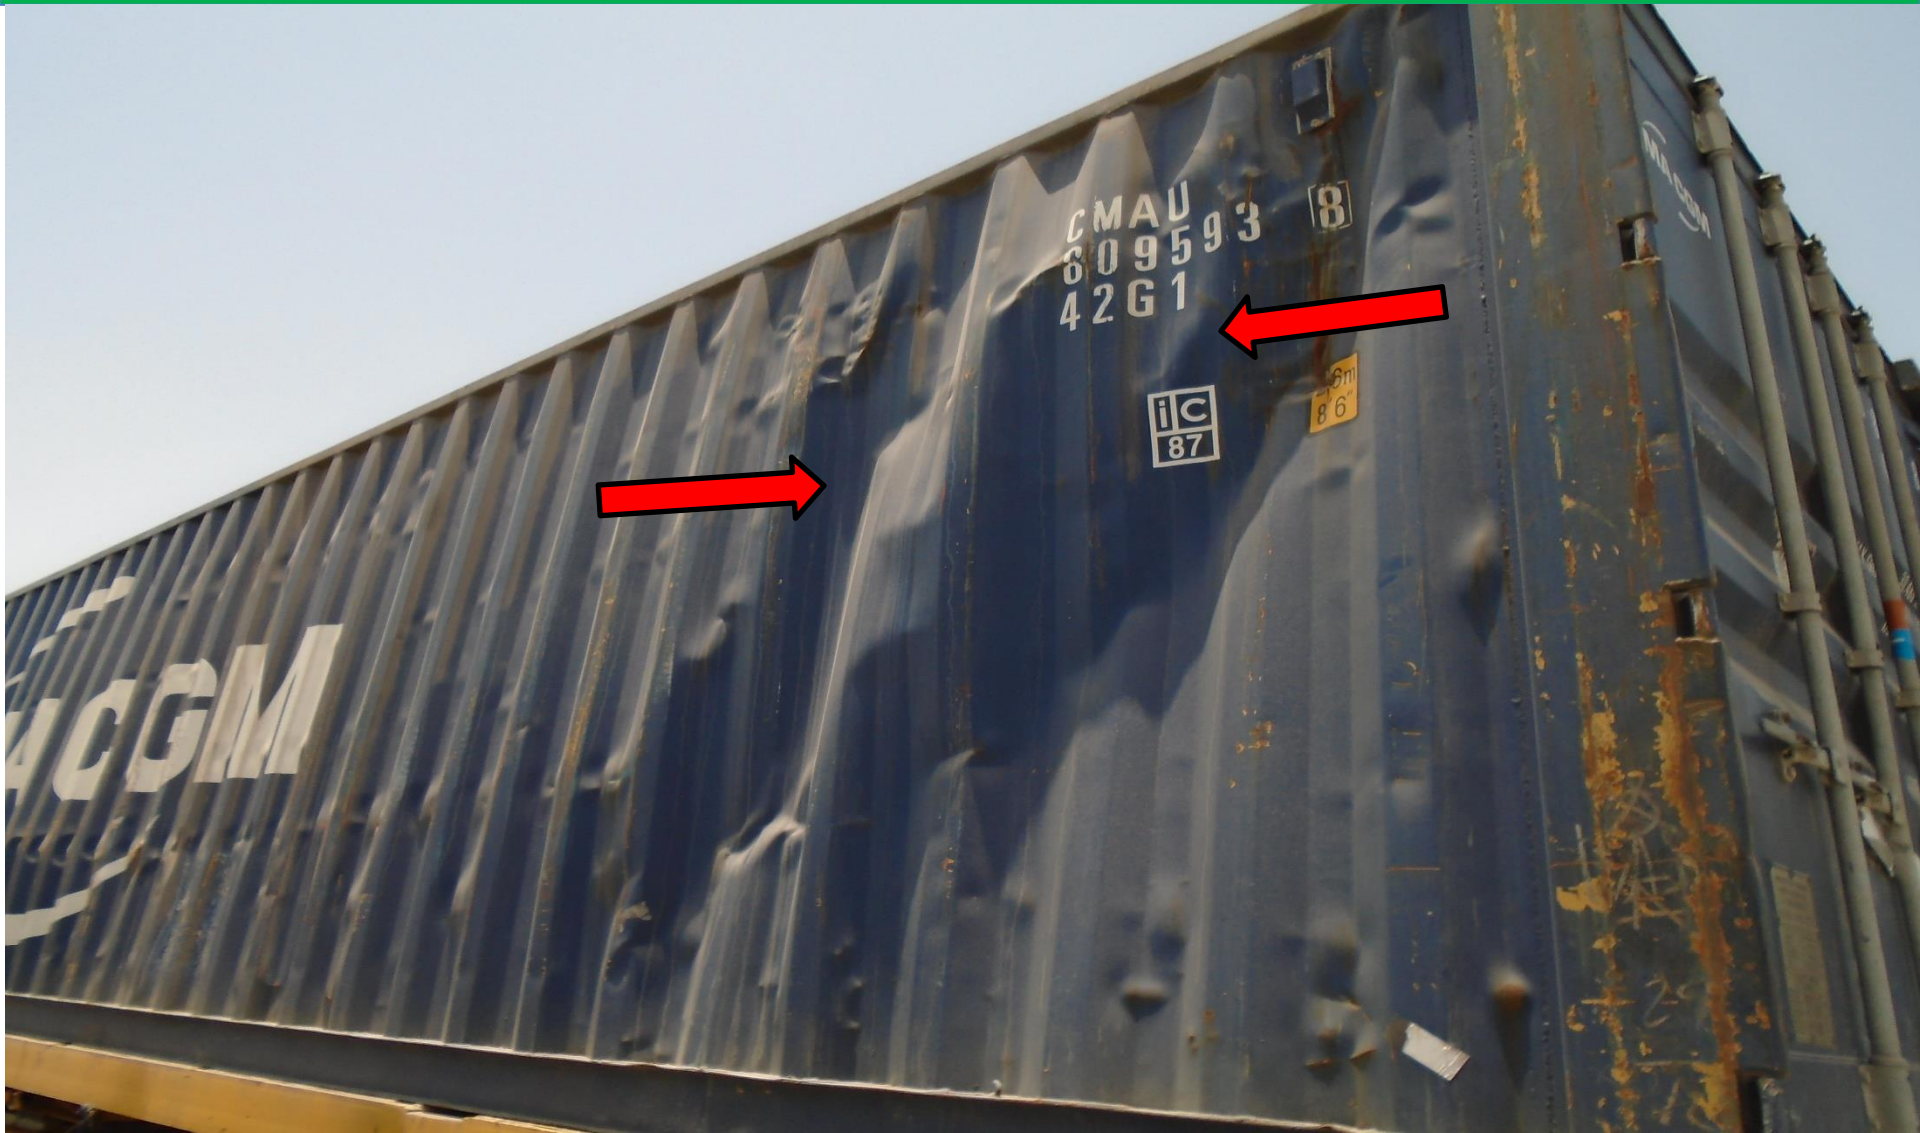
# Dents/Bulge In/Out

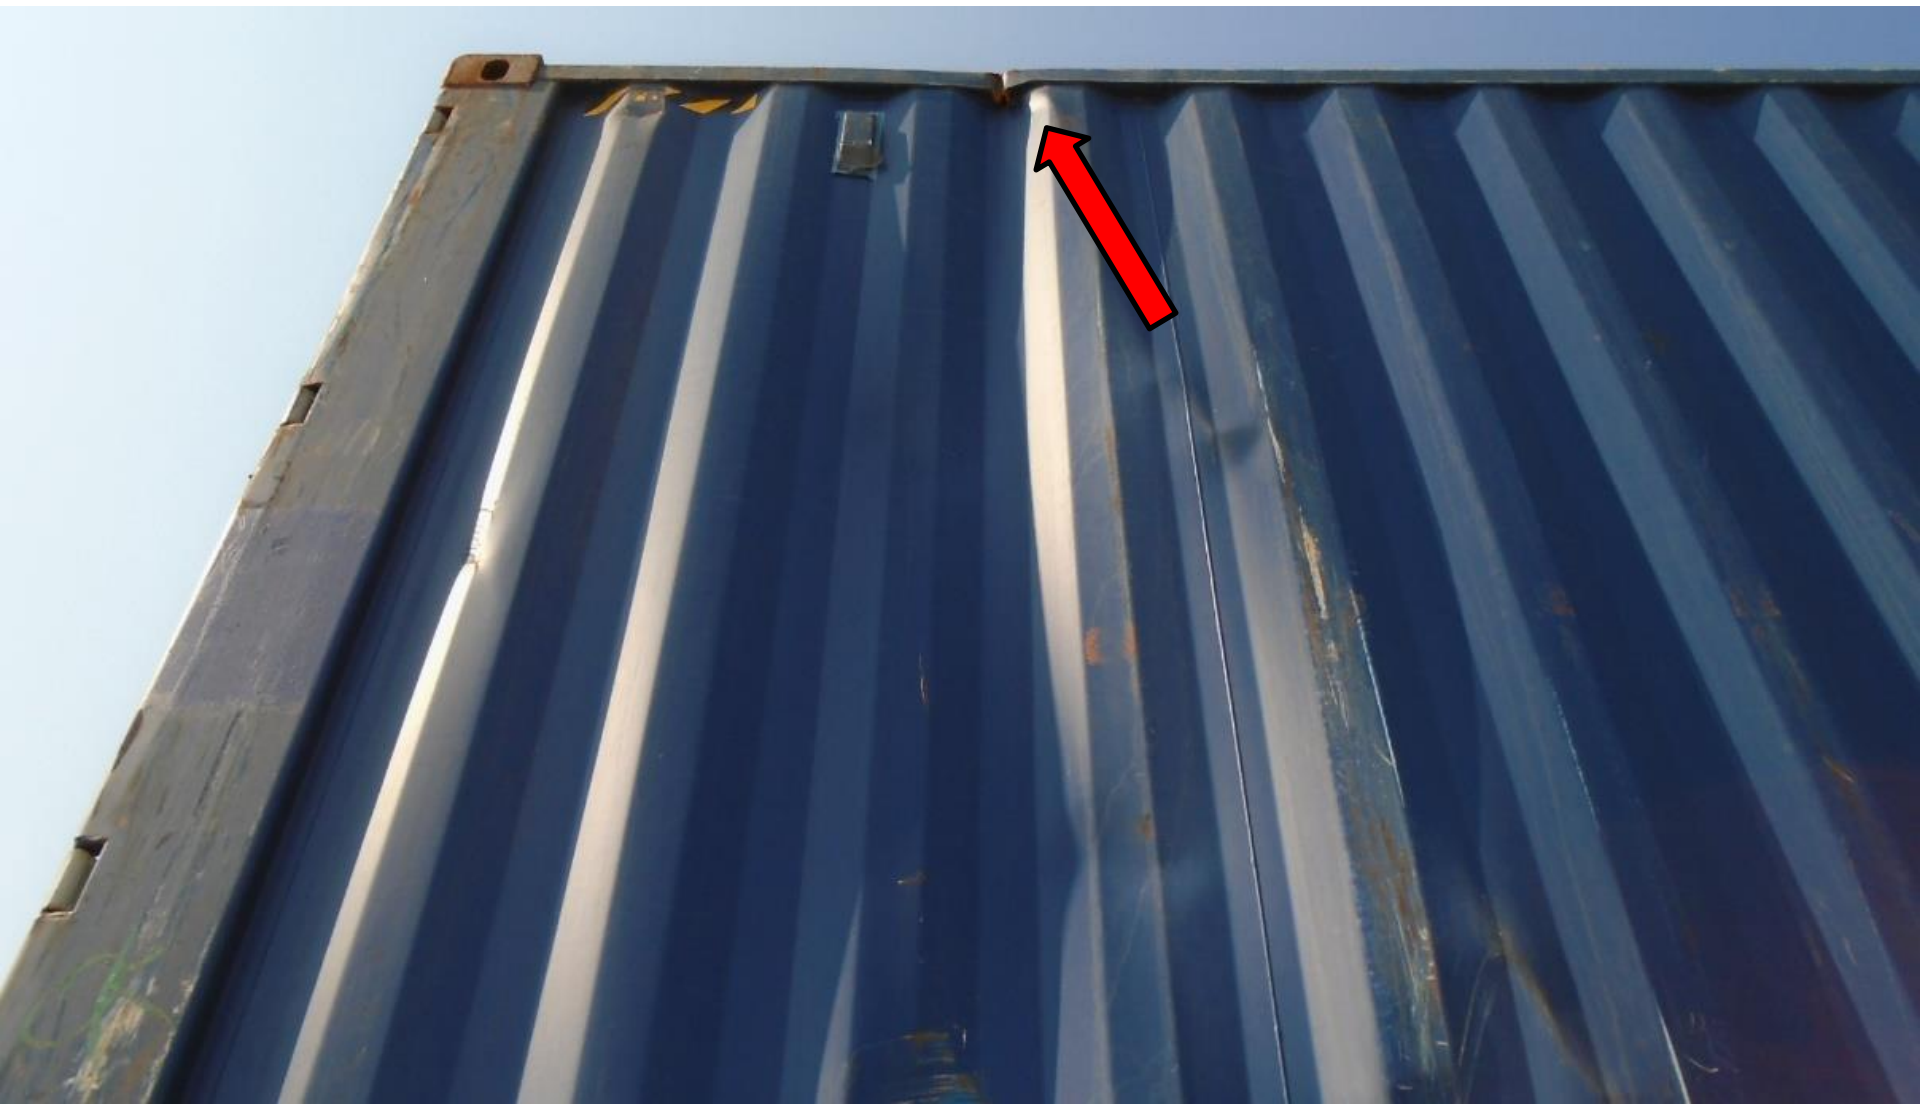
# Dent with Cut

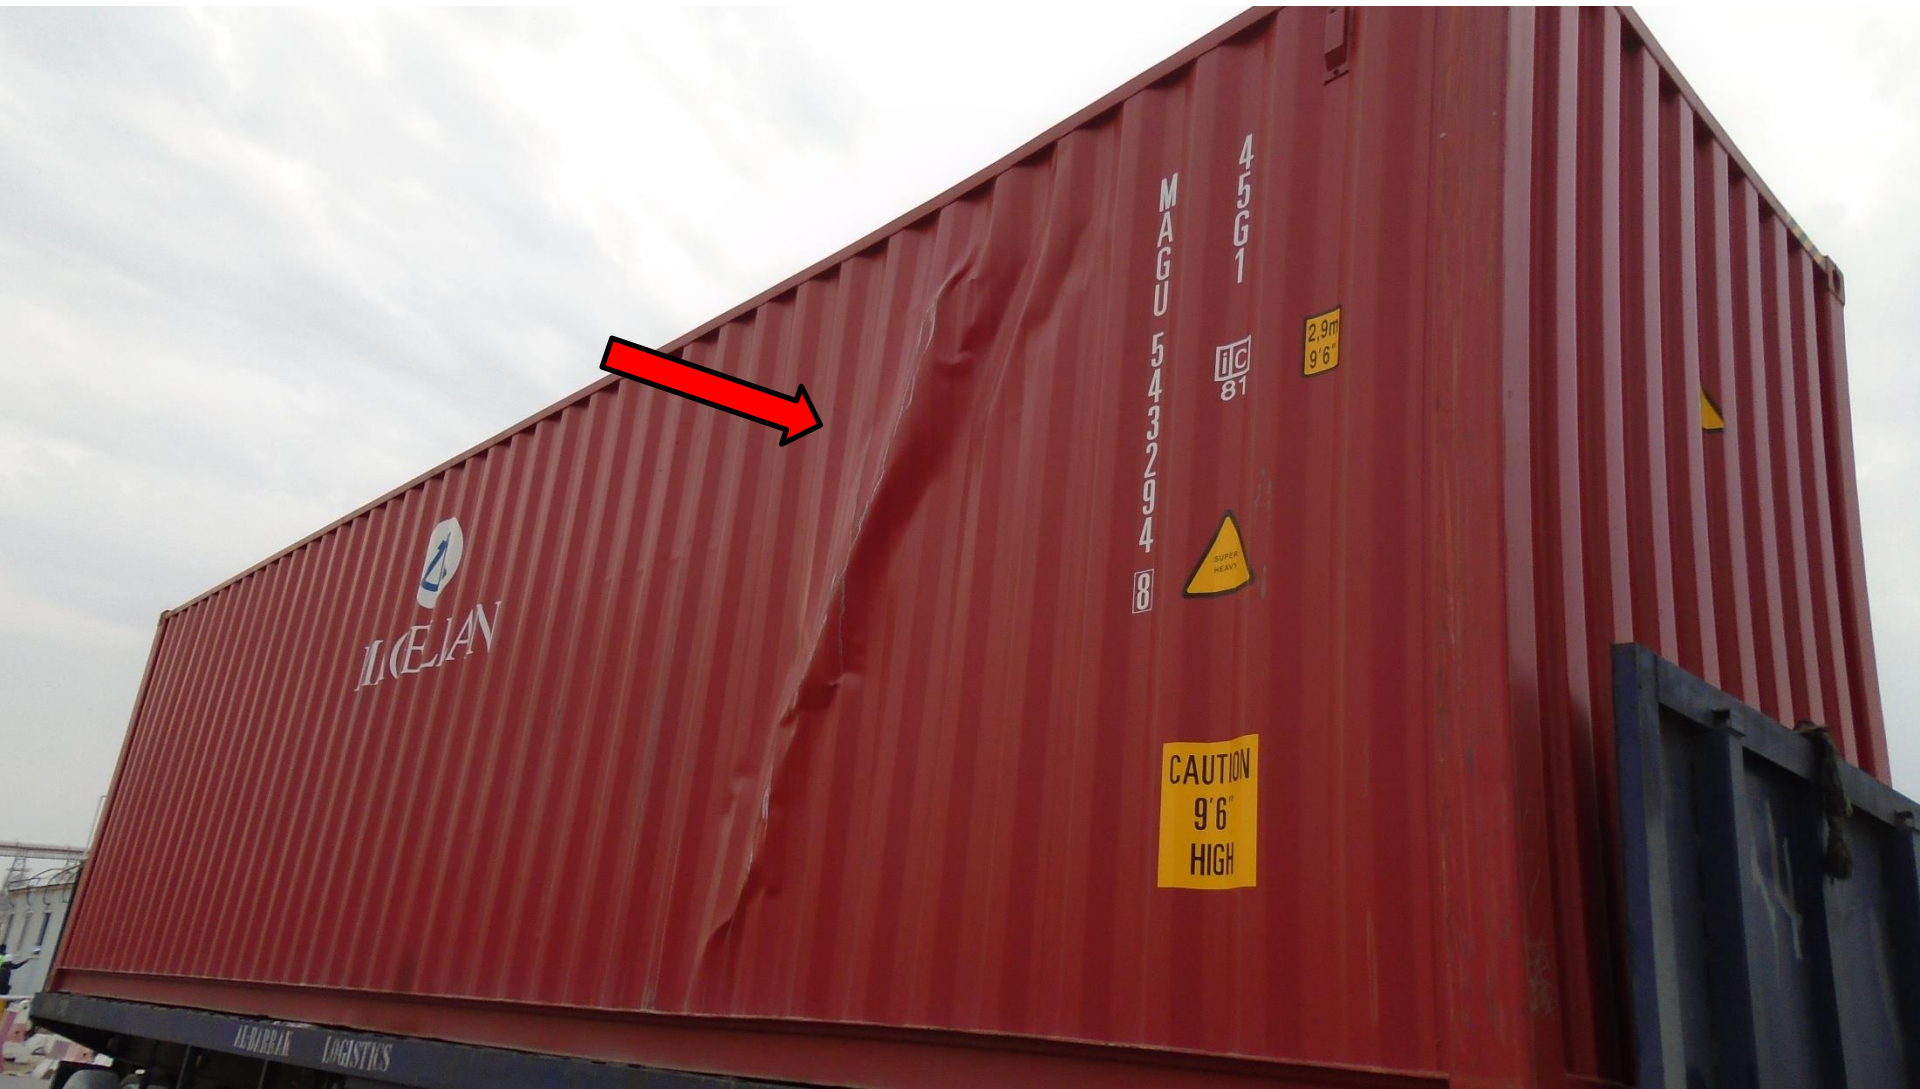
# Dented/Push In/Out (Major Damage)

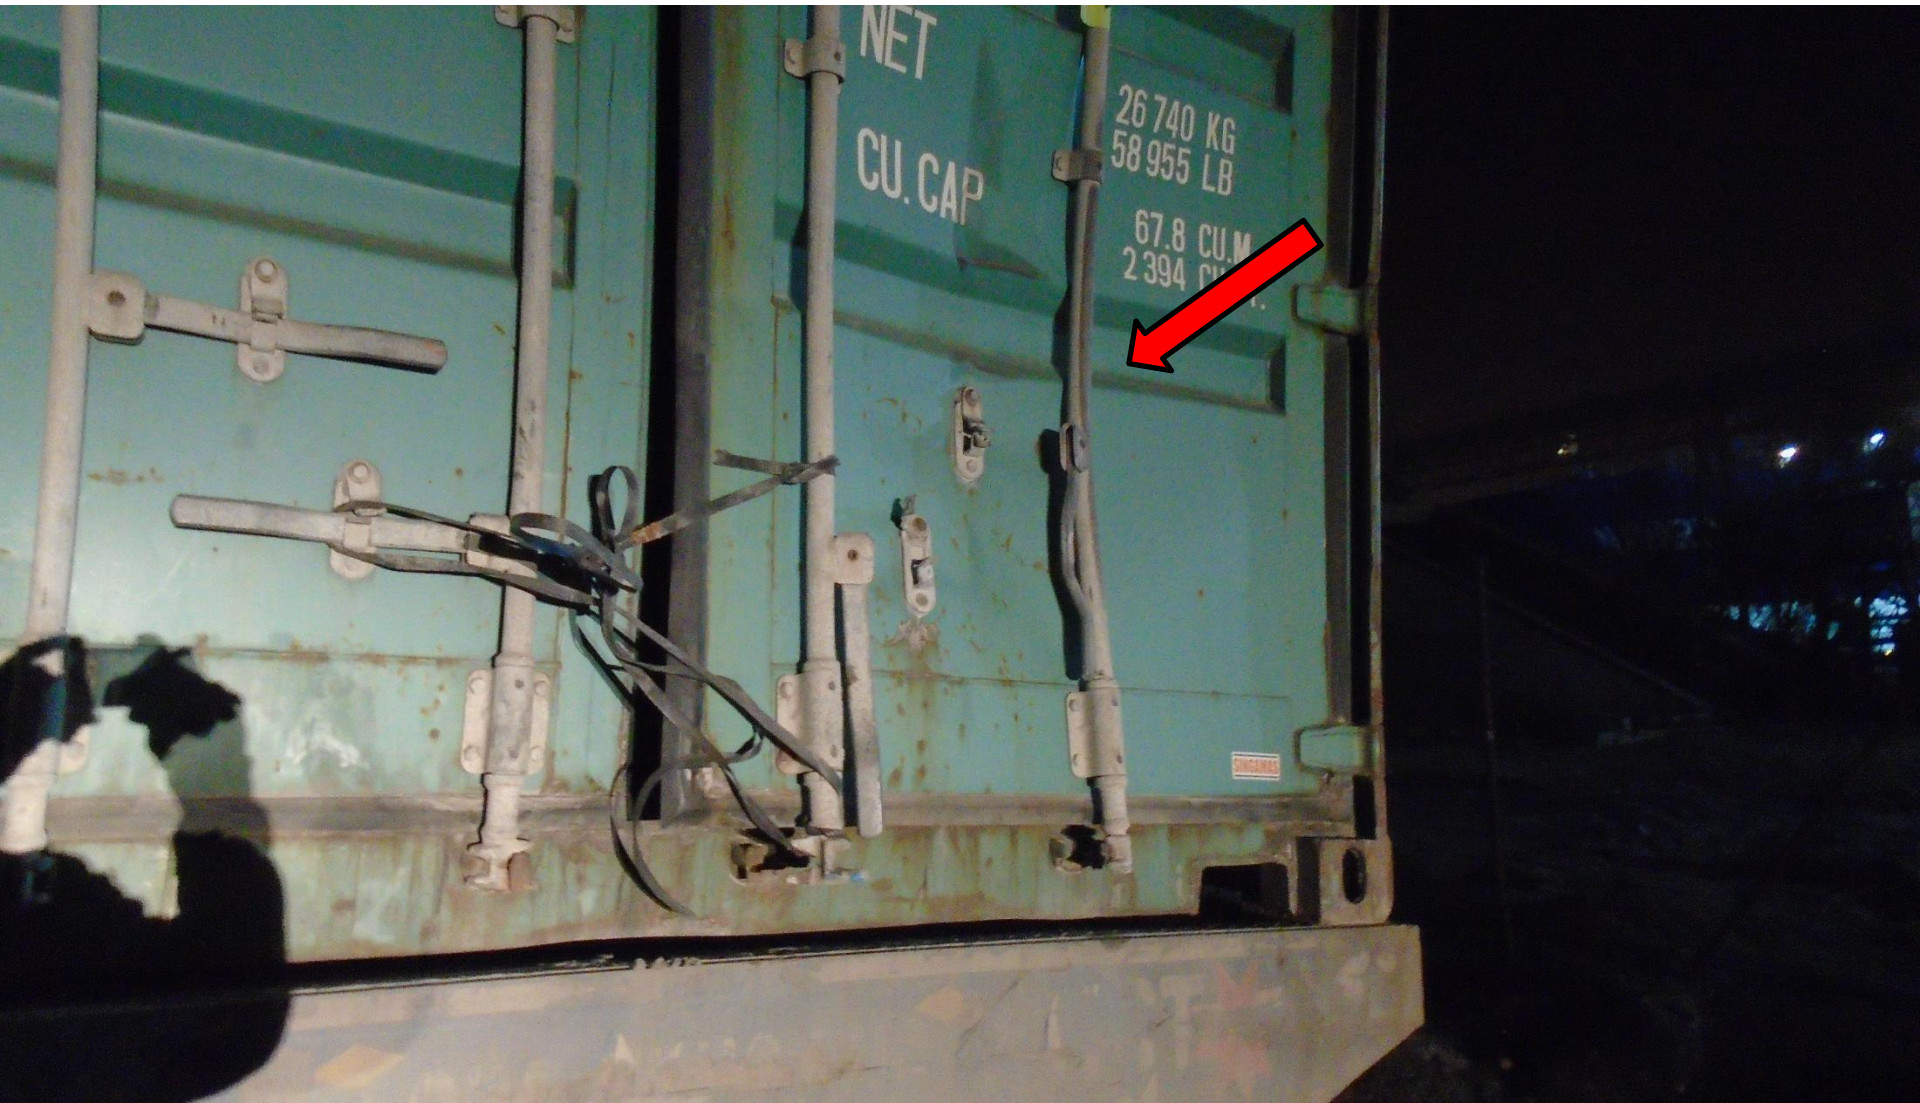
# Bent Locking Long Bar (Major Damage)

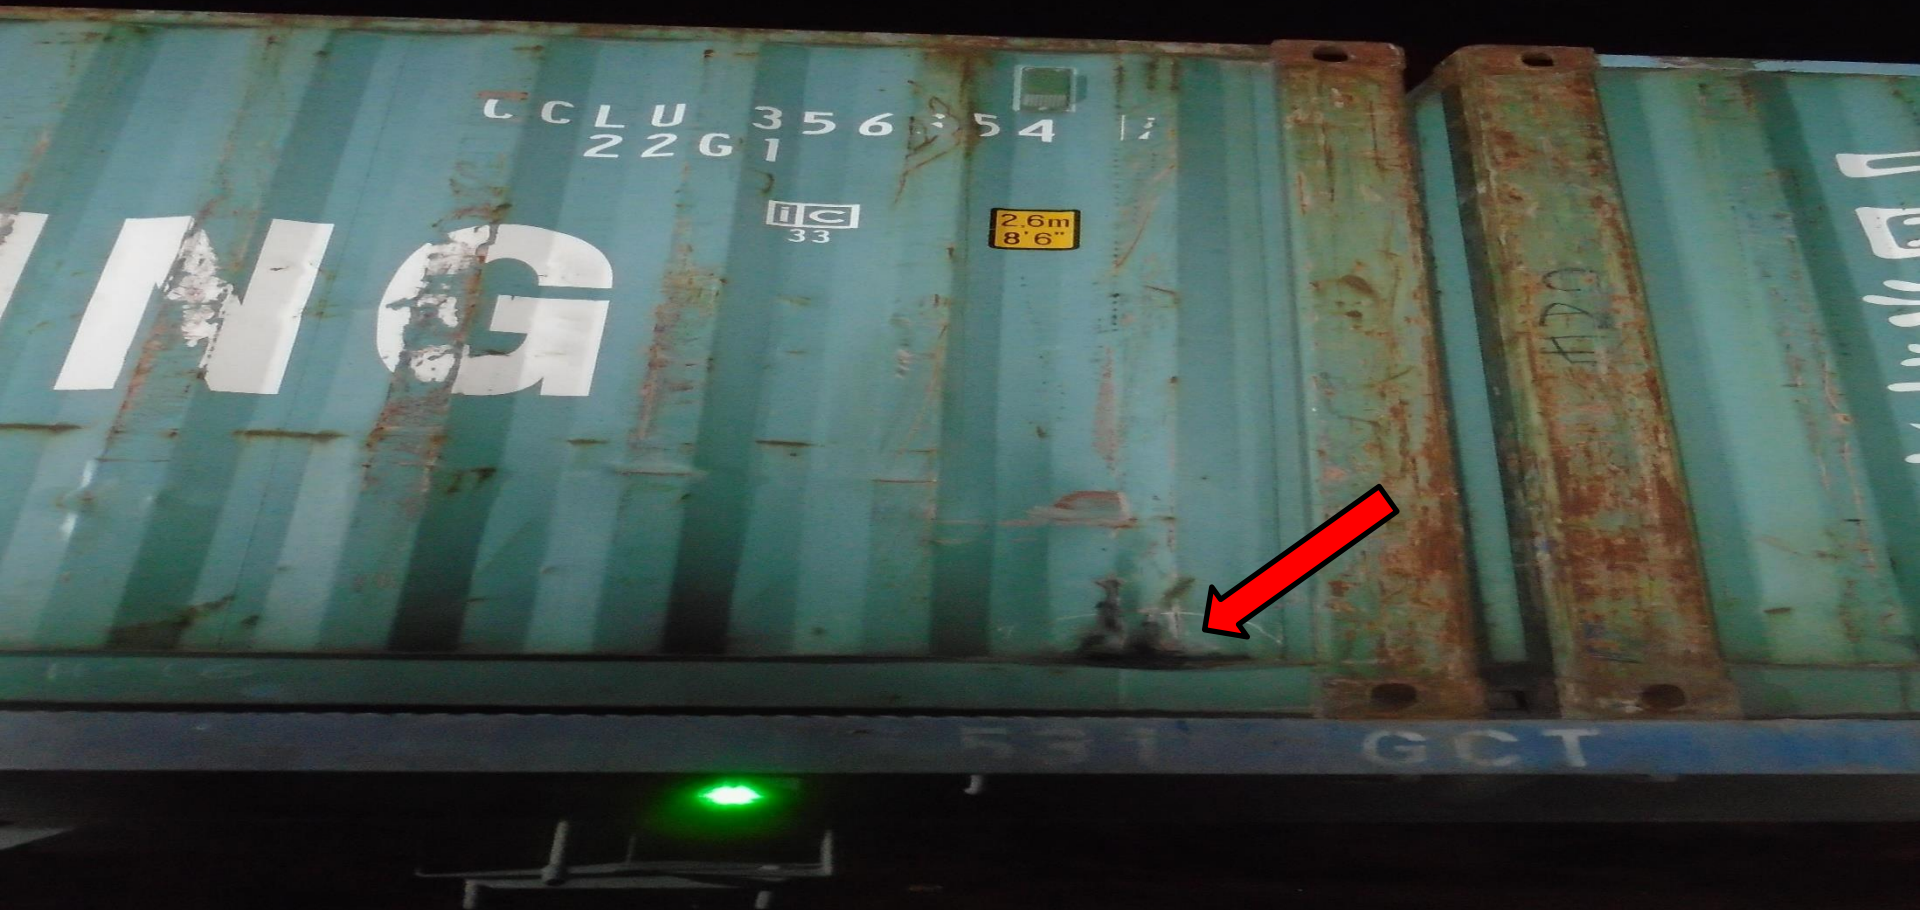
Cut side panel below

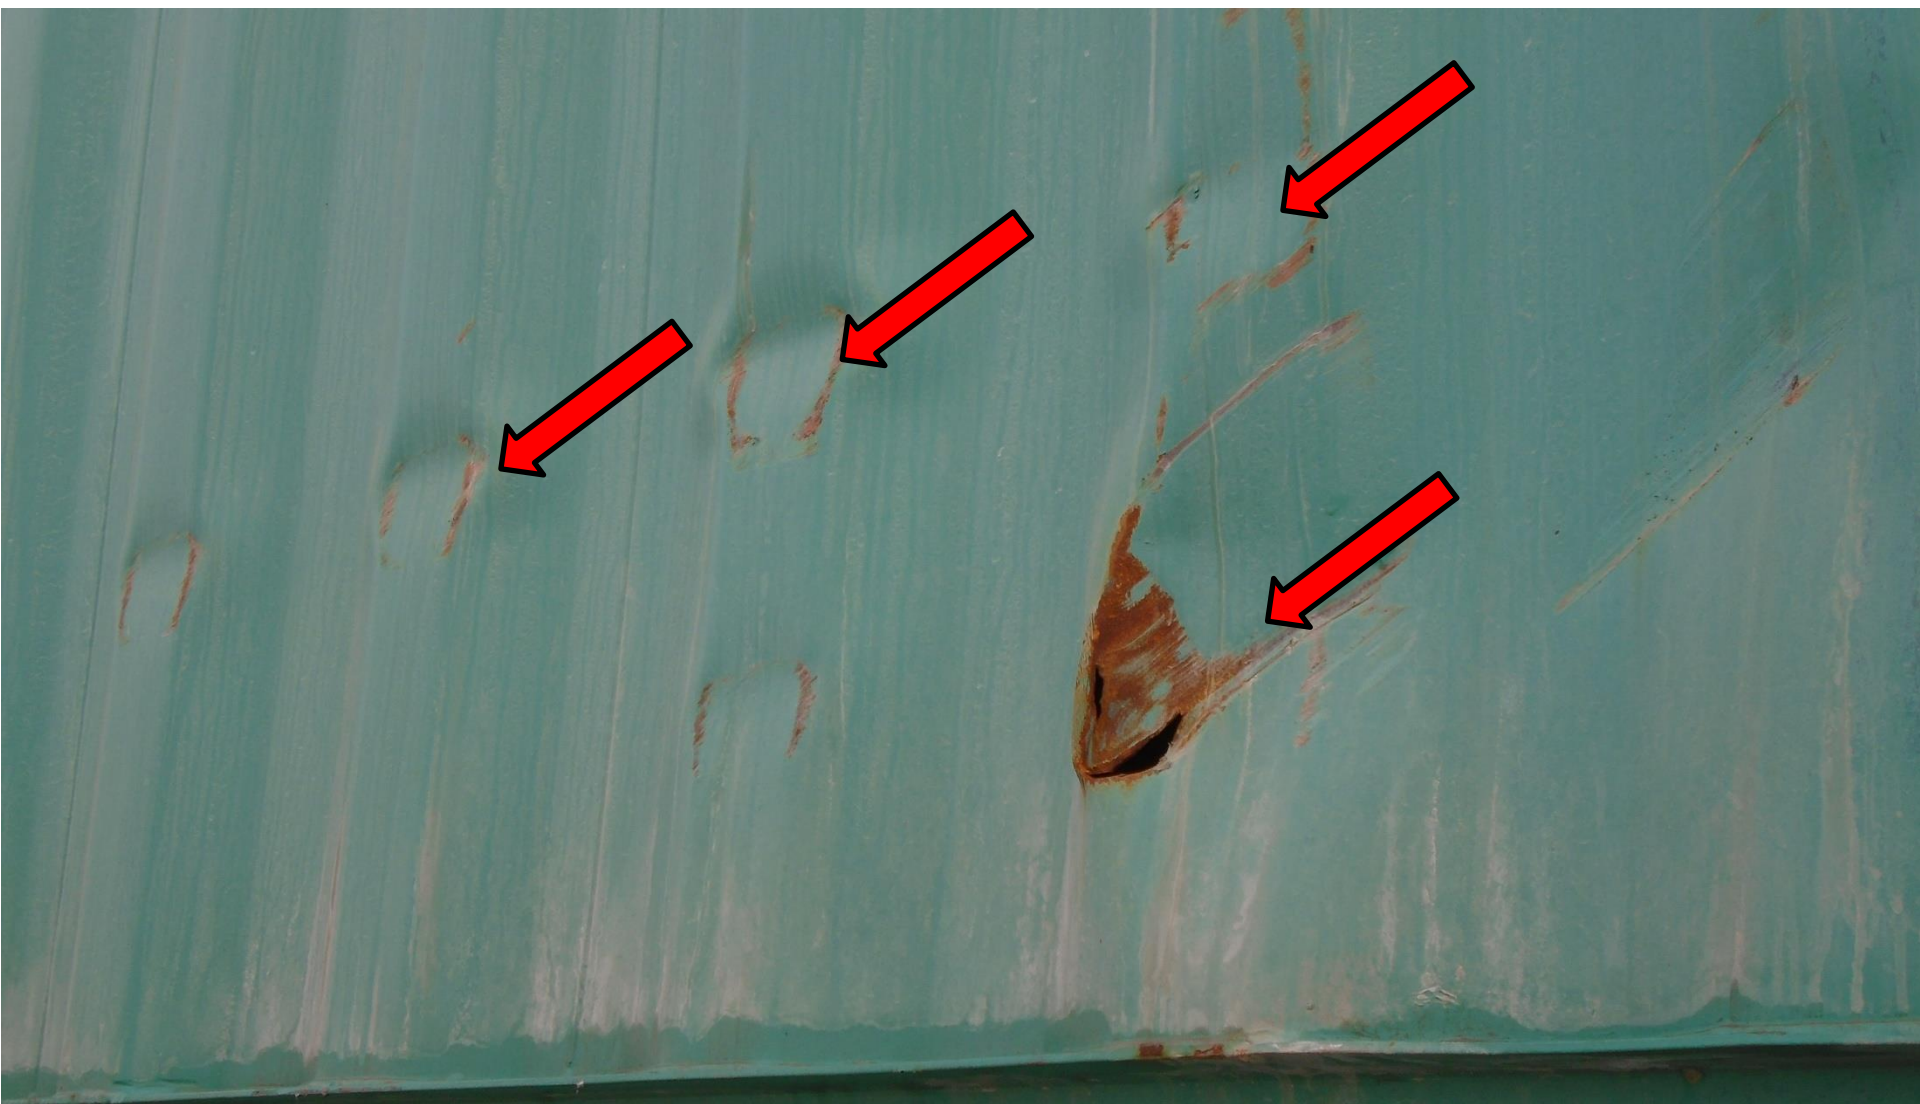
# Cut and Dents

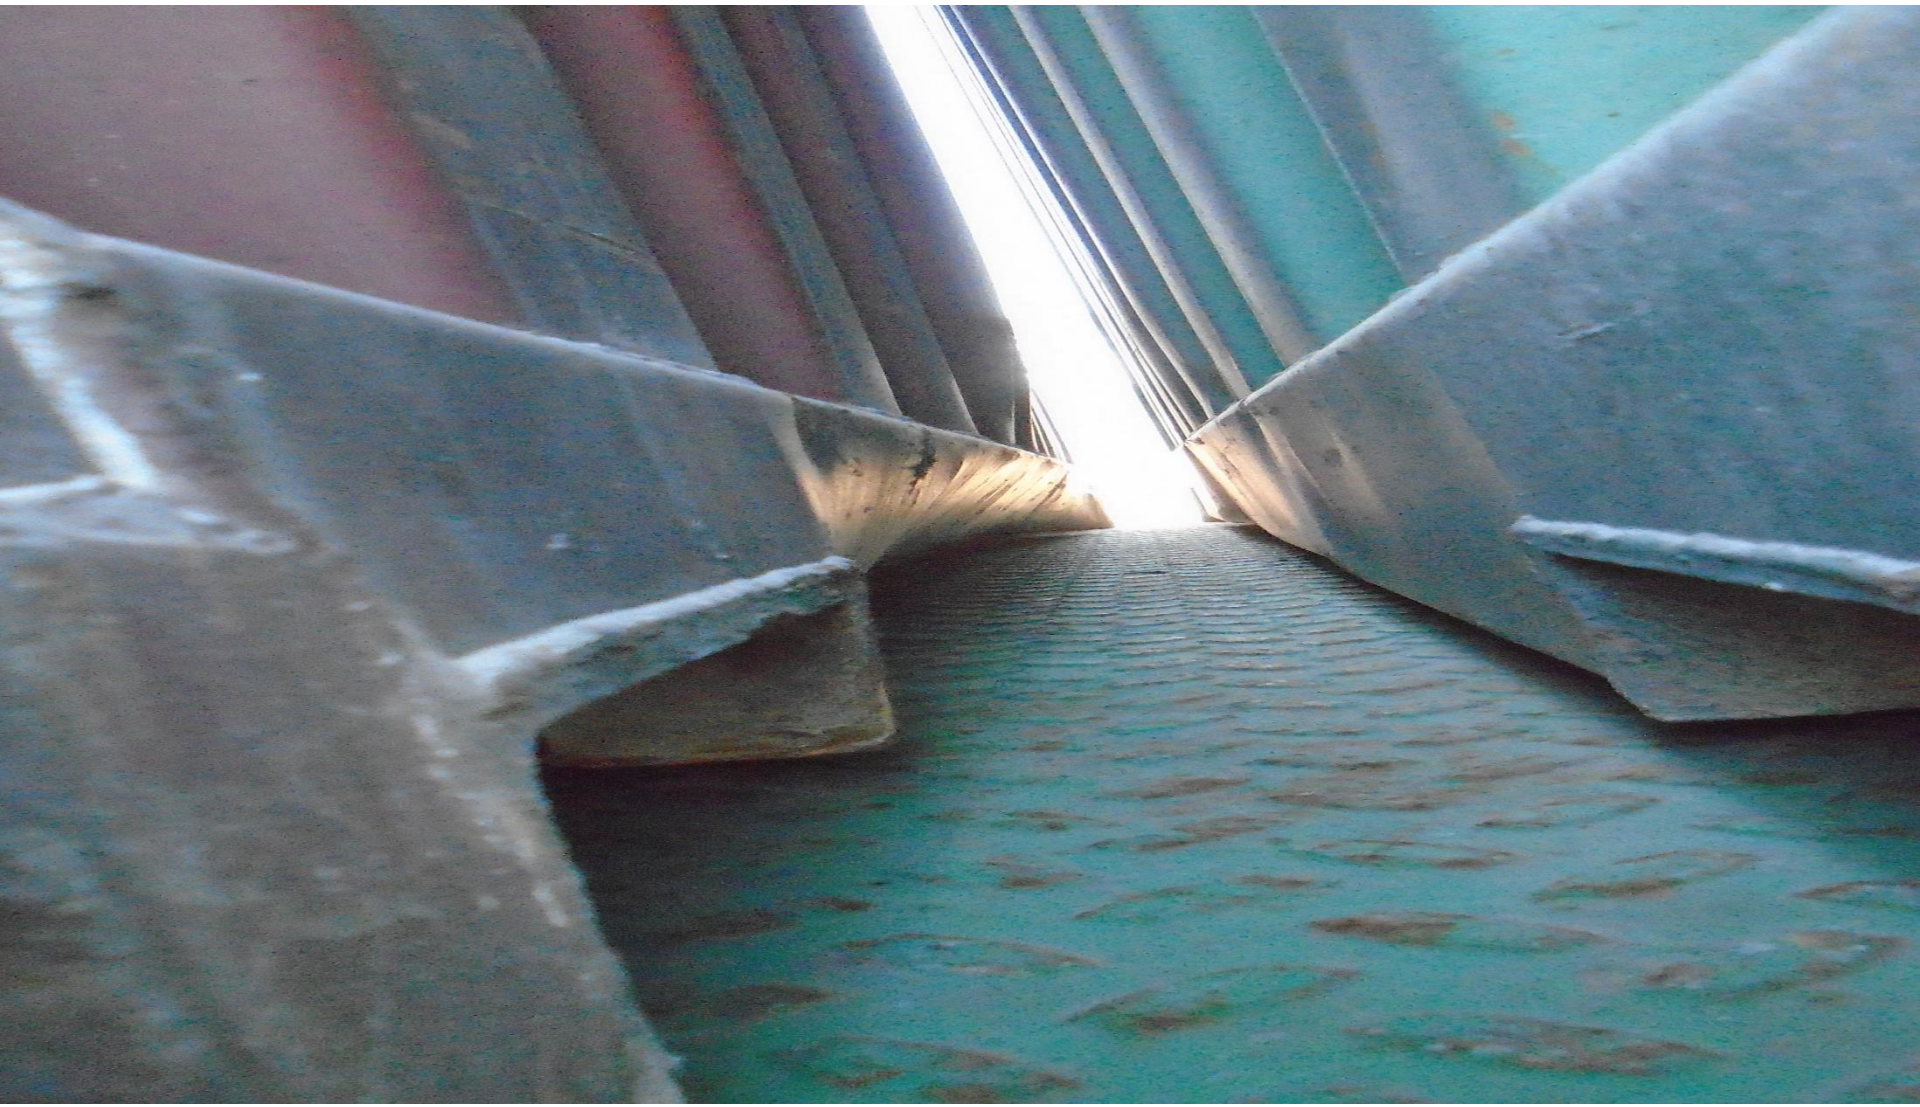
# Dent Front Bottom Rail (In Between 2x20')

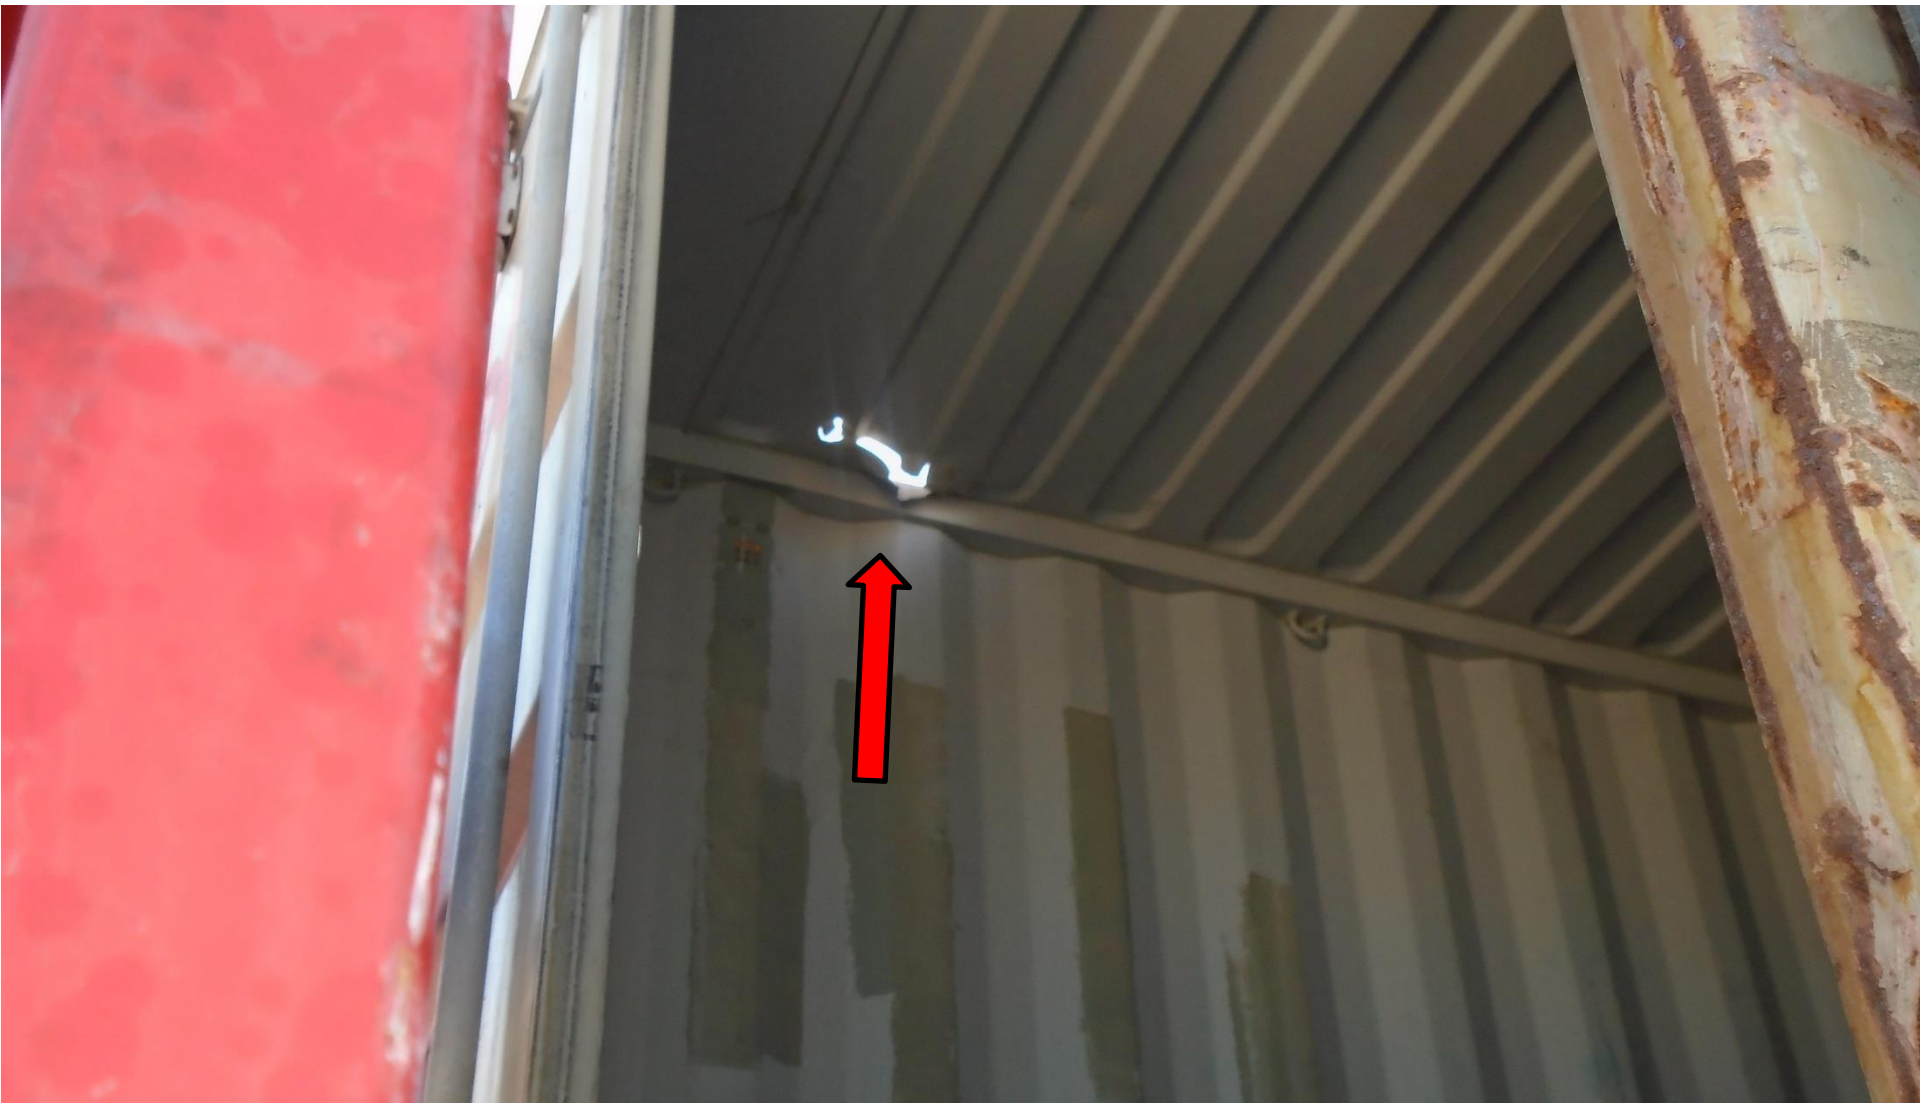
# Cut/Hole Top Panel (Major Damage)

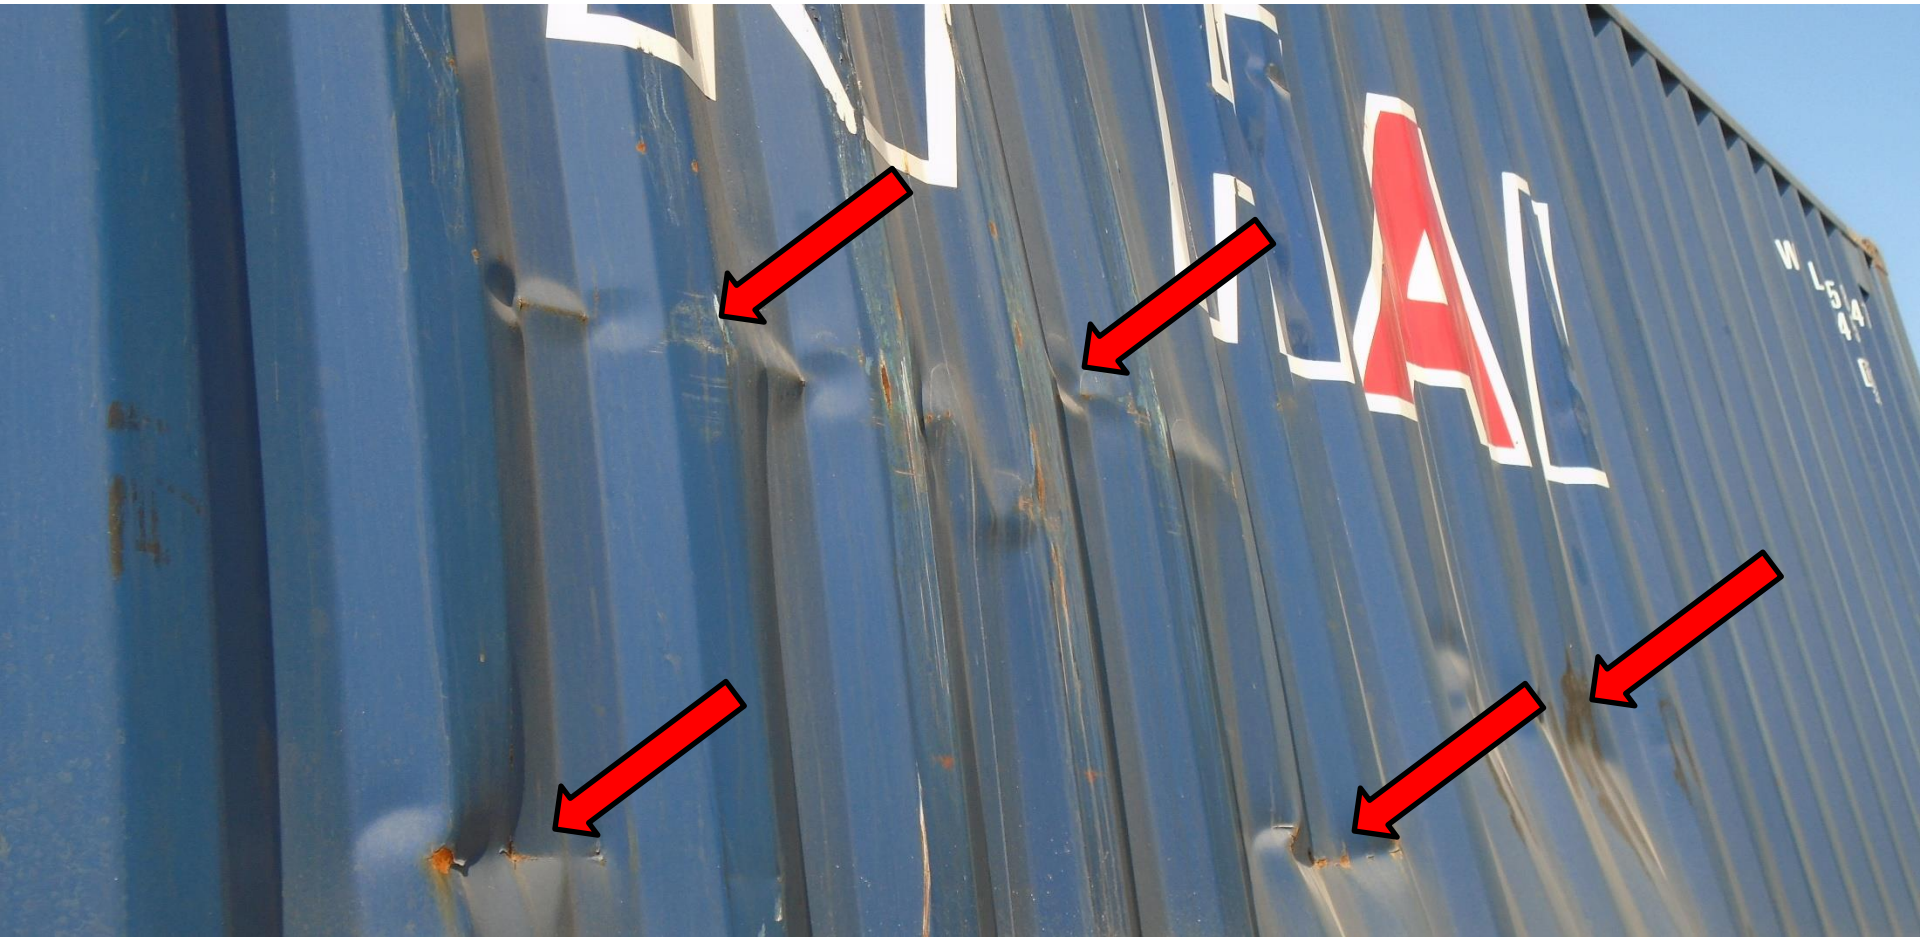
# Dents and Push In/Out

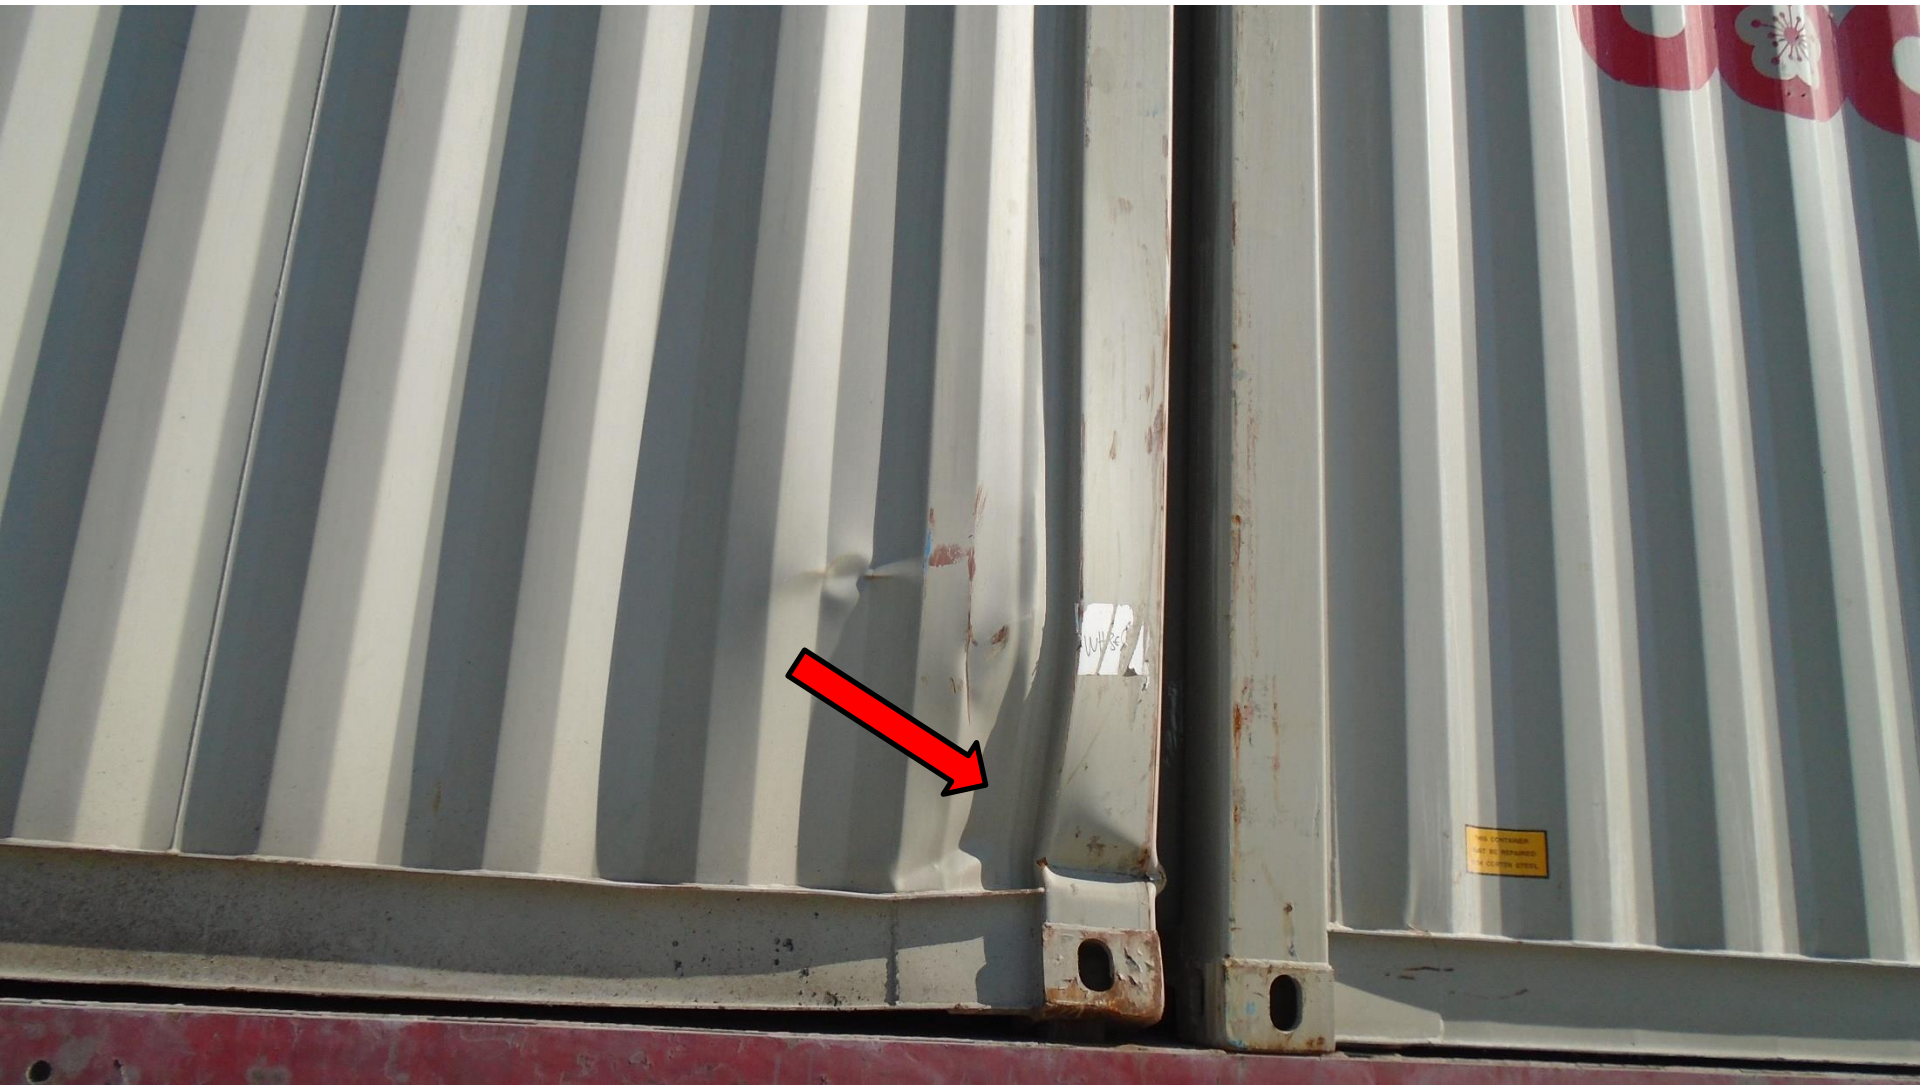
# Bent Corner Post/Casting (Major Damage)

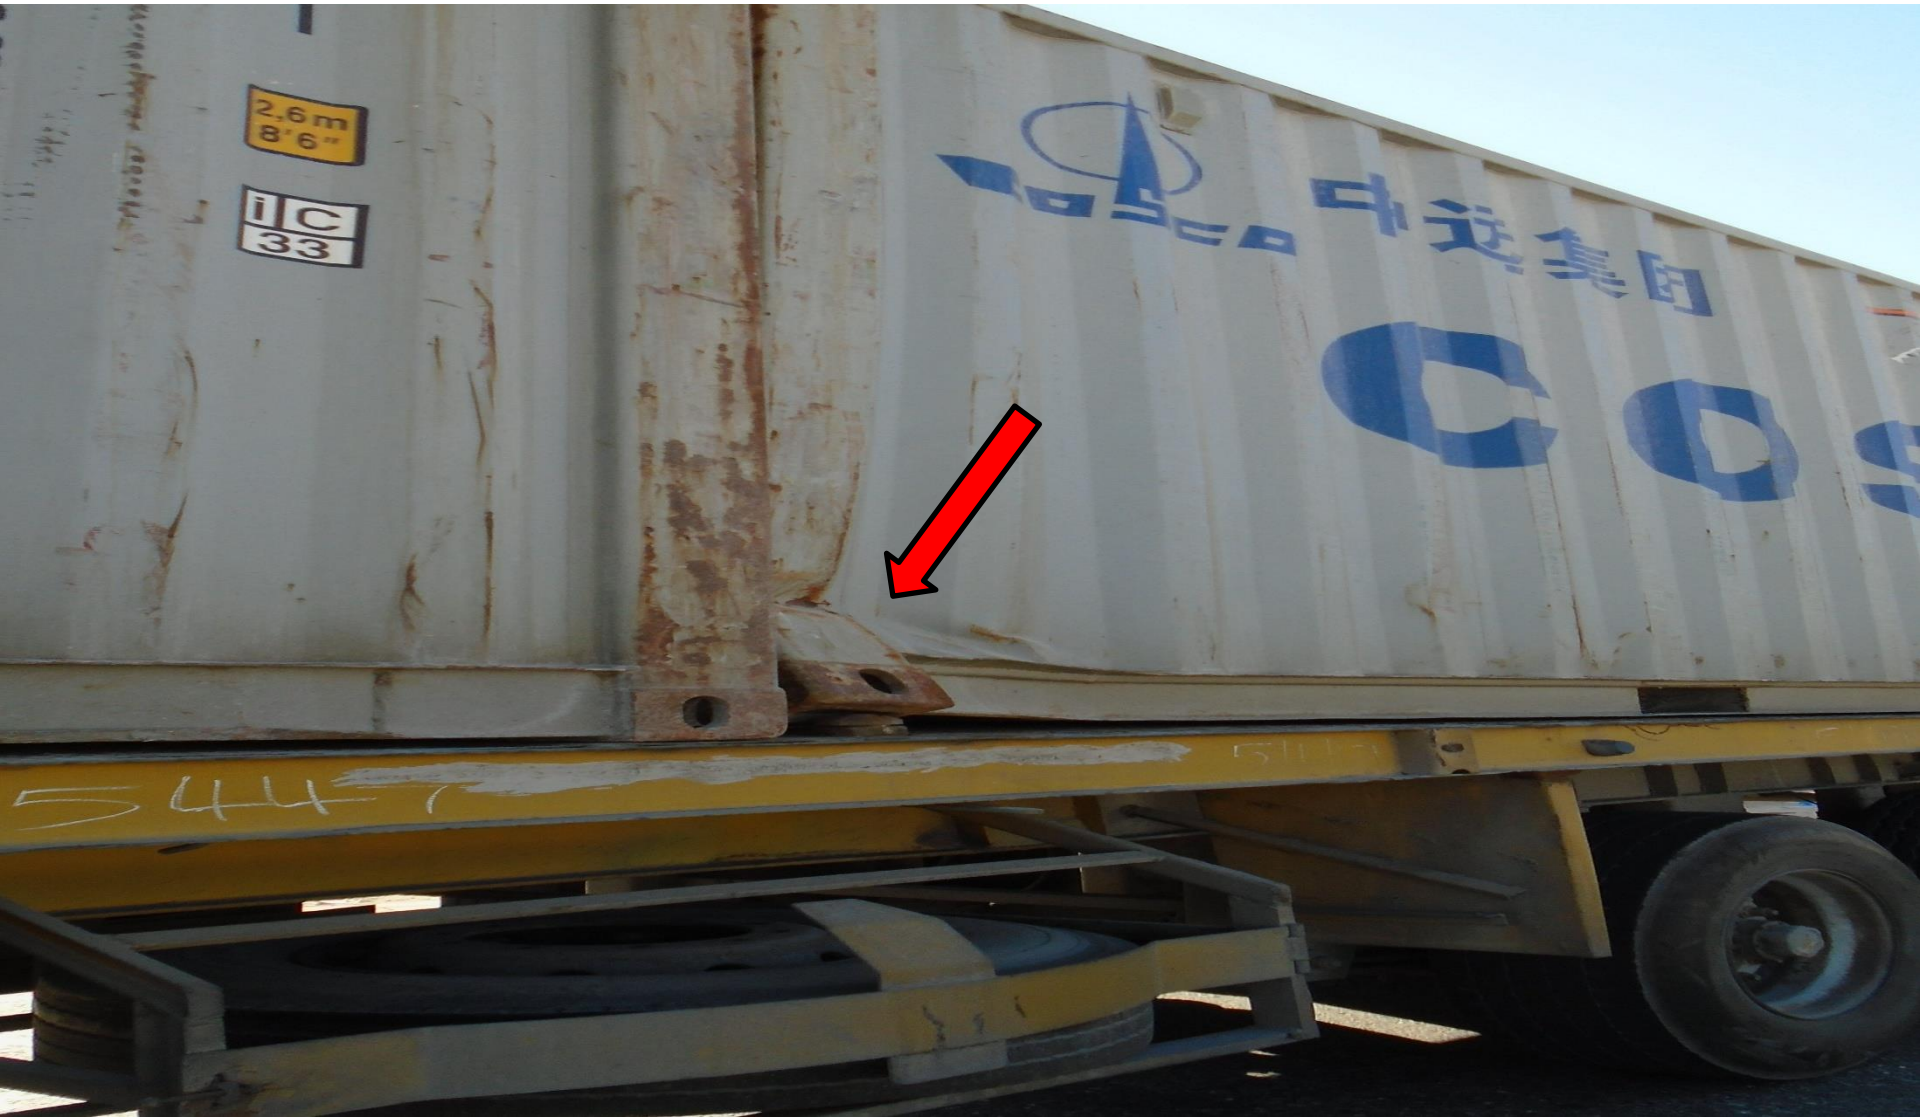
# Bent Corner Post/Casting (Major Damage)
