SAUDI GLOBAL PORTS

## Other type of damages

## CONTAINER DAMAGE CODES

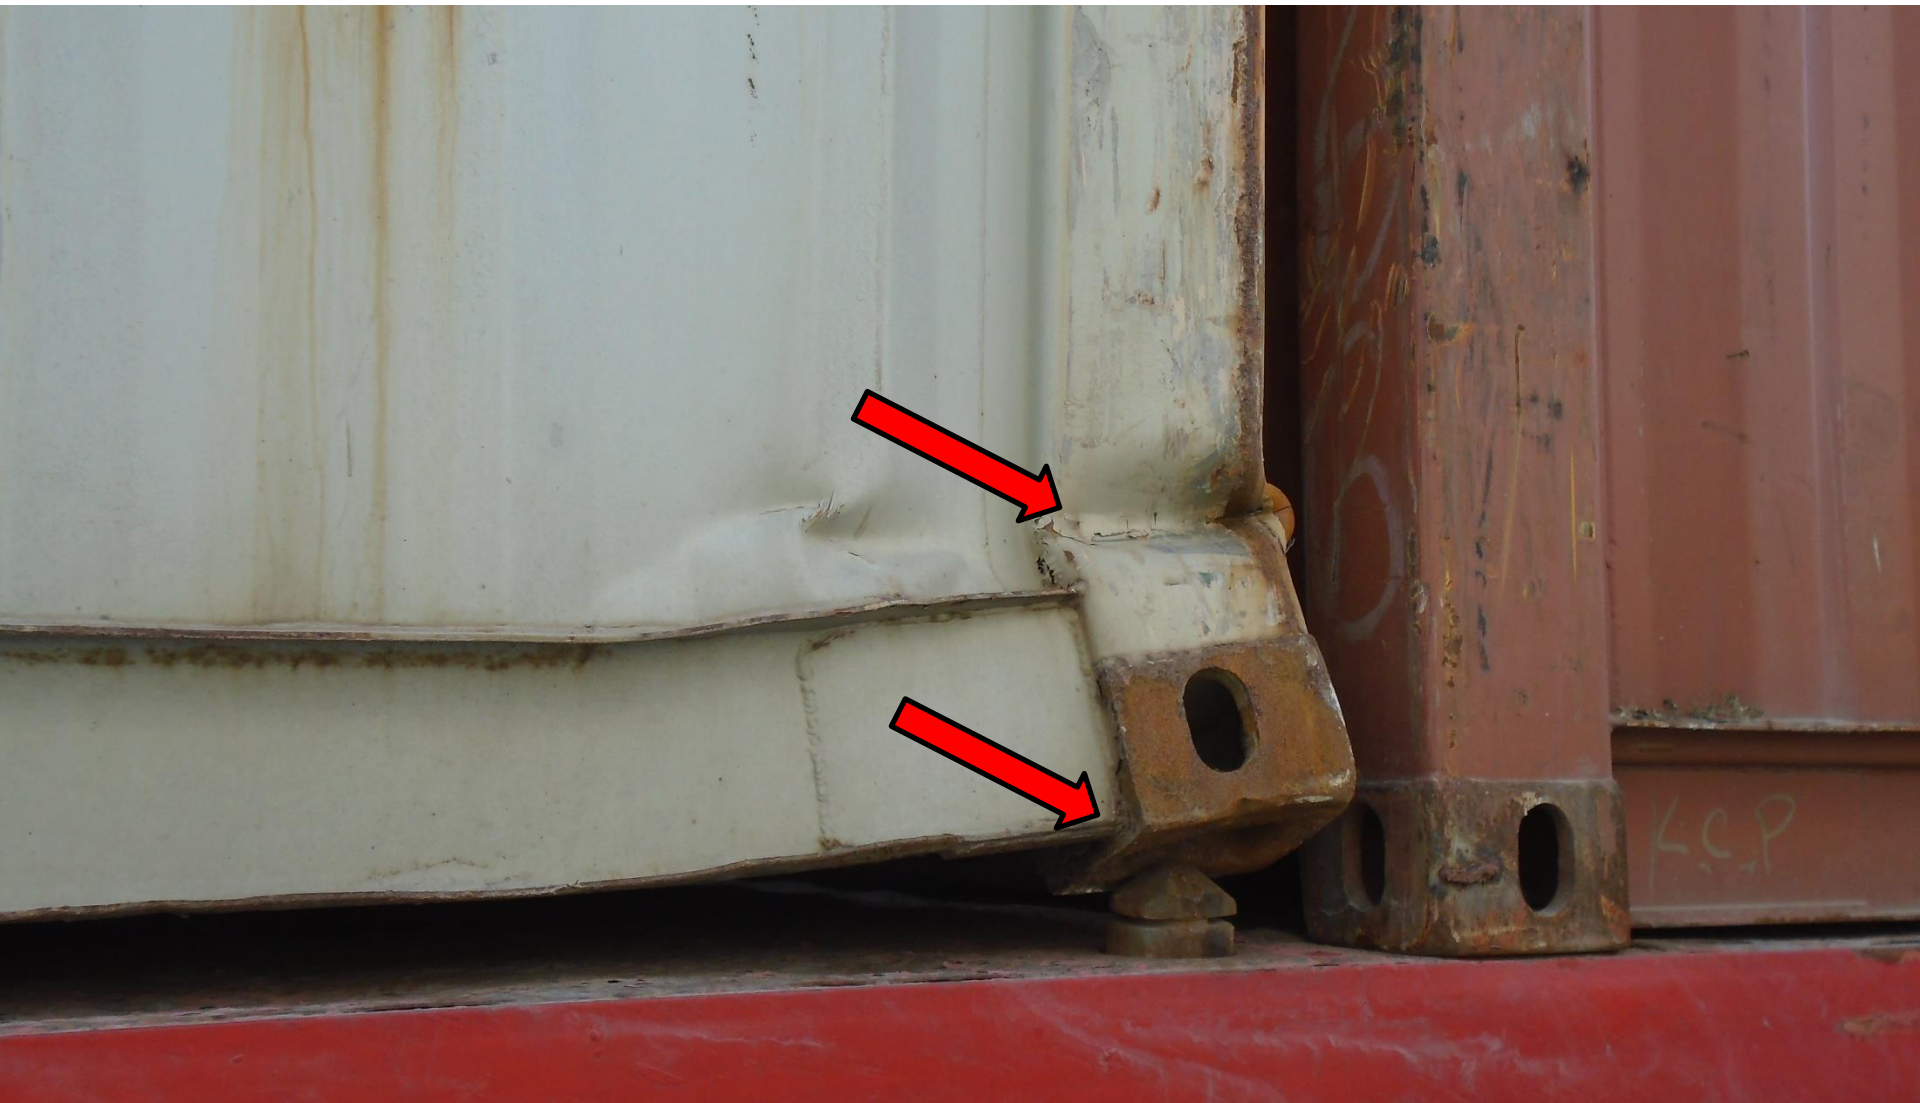
# Bent Corner Post/Casting (Major Damage)

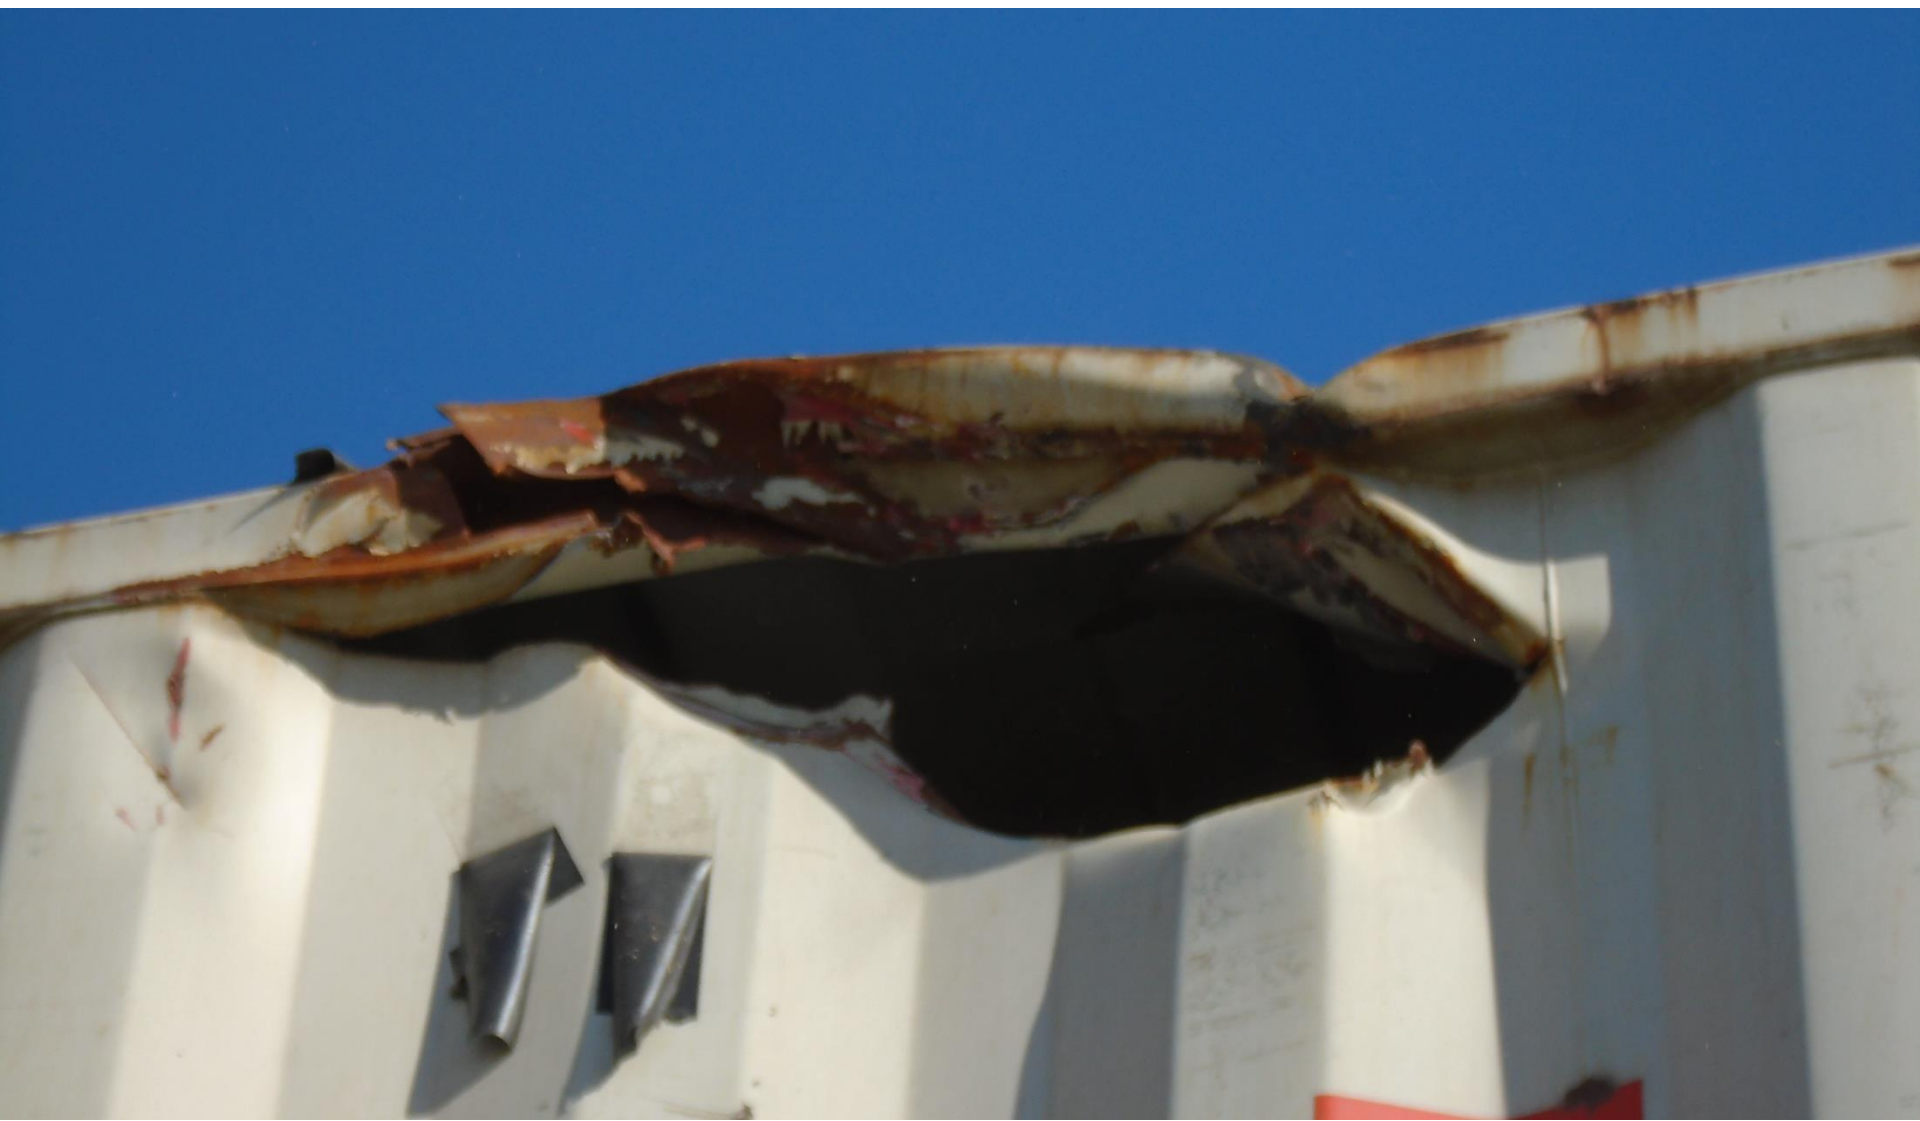
# Big Cut @ the top panel (Major Damage)

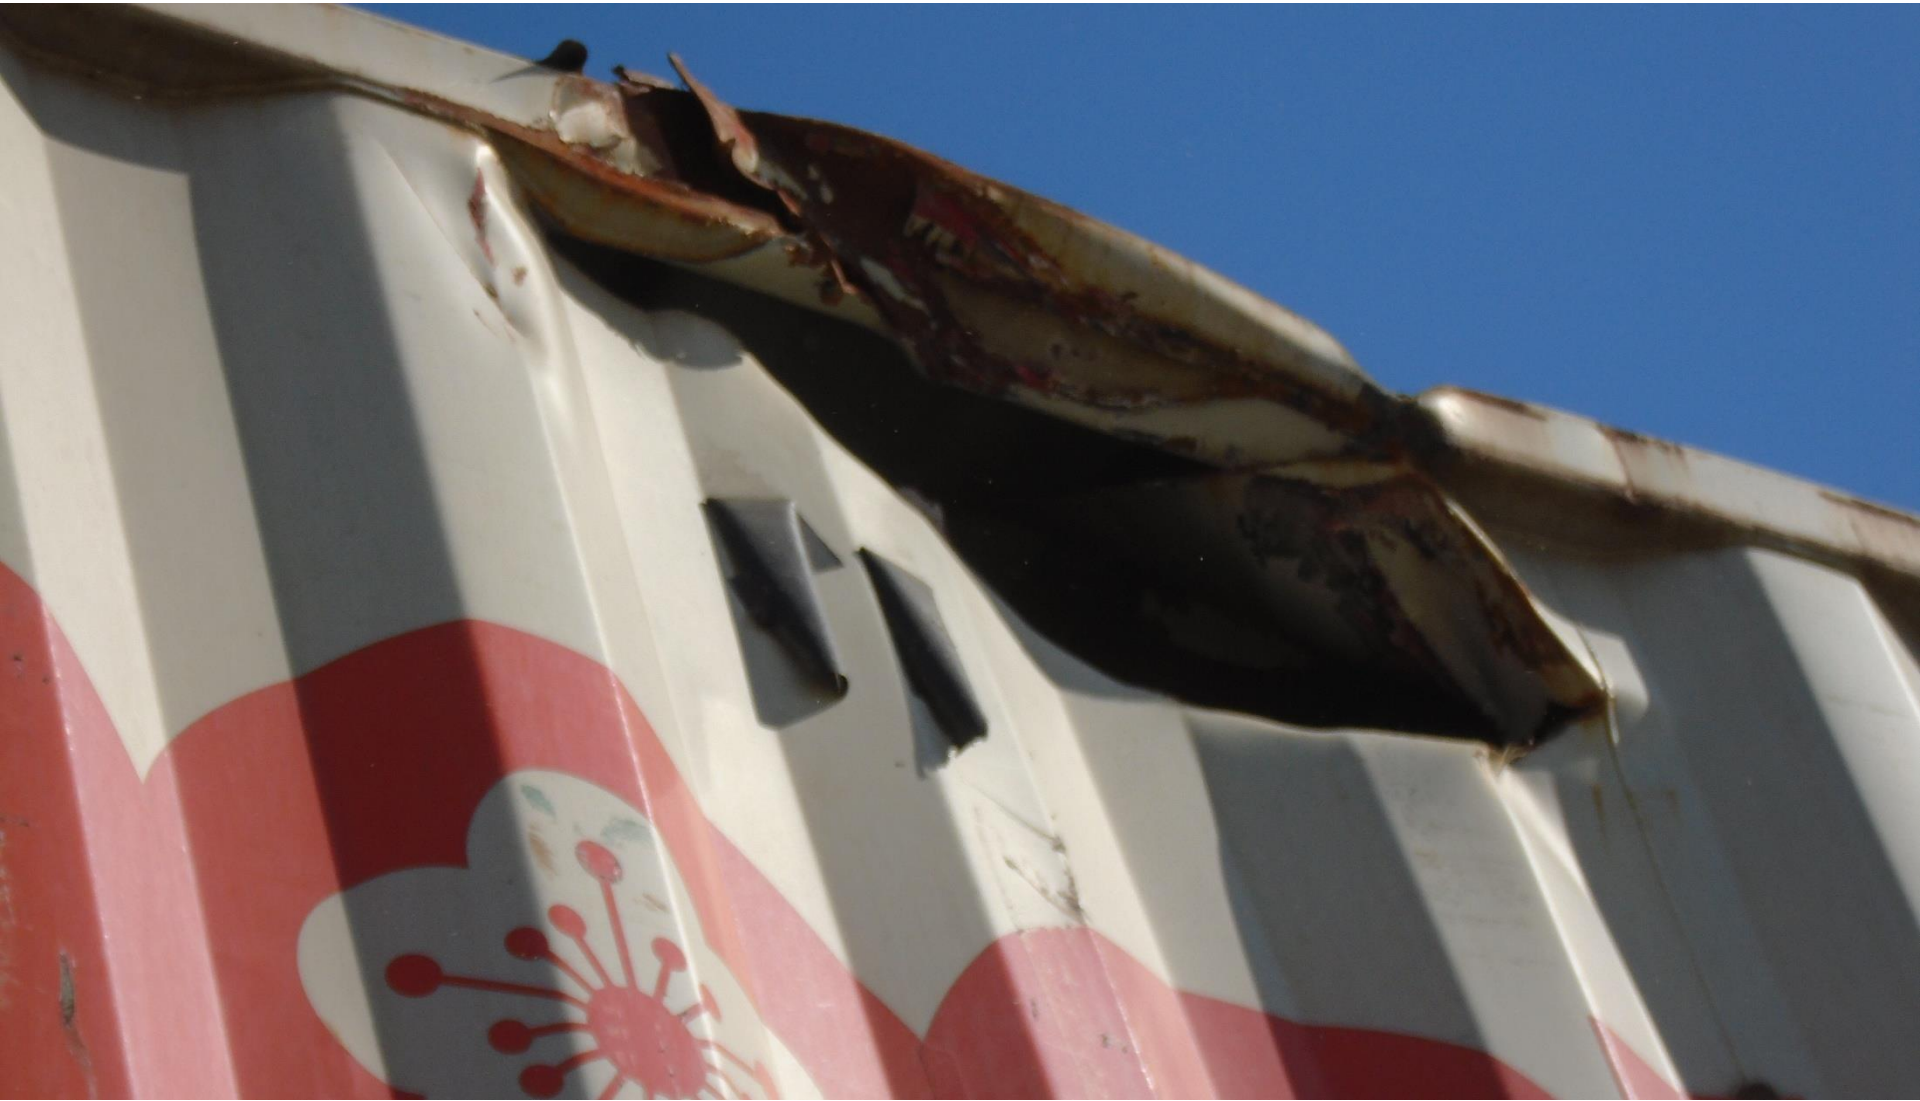
# Big Cut @ the top panel (Major Damage)

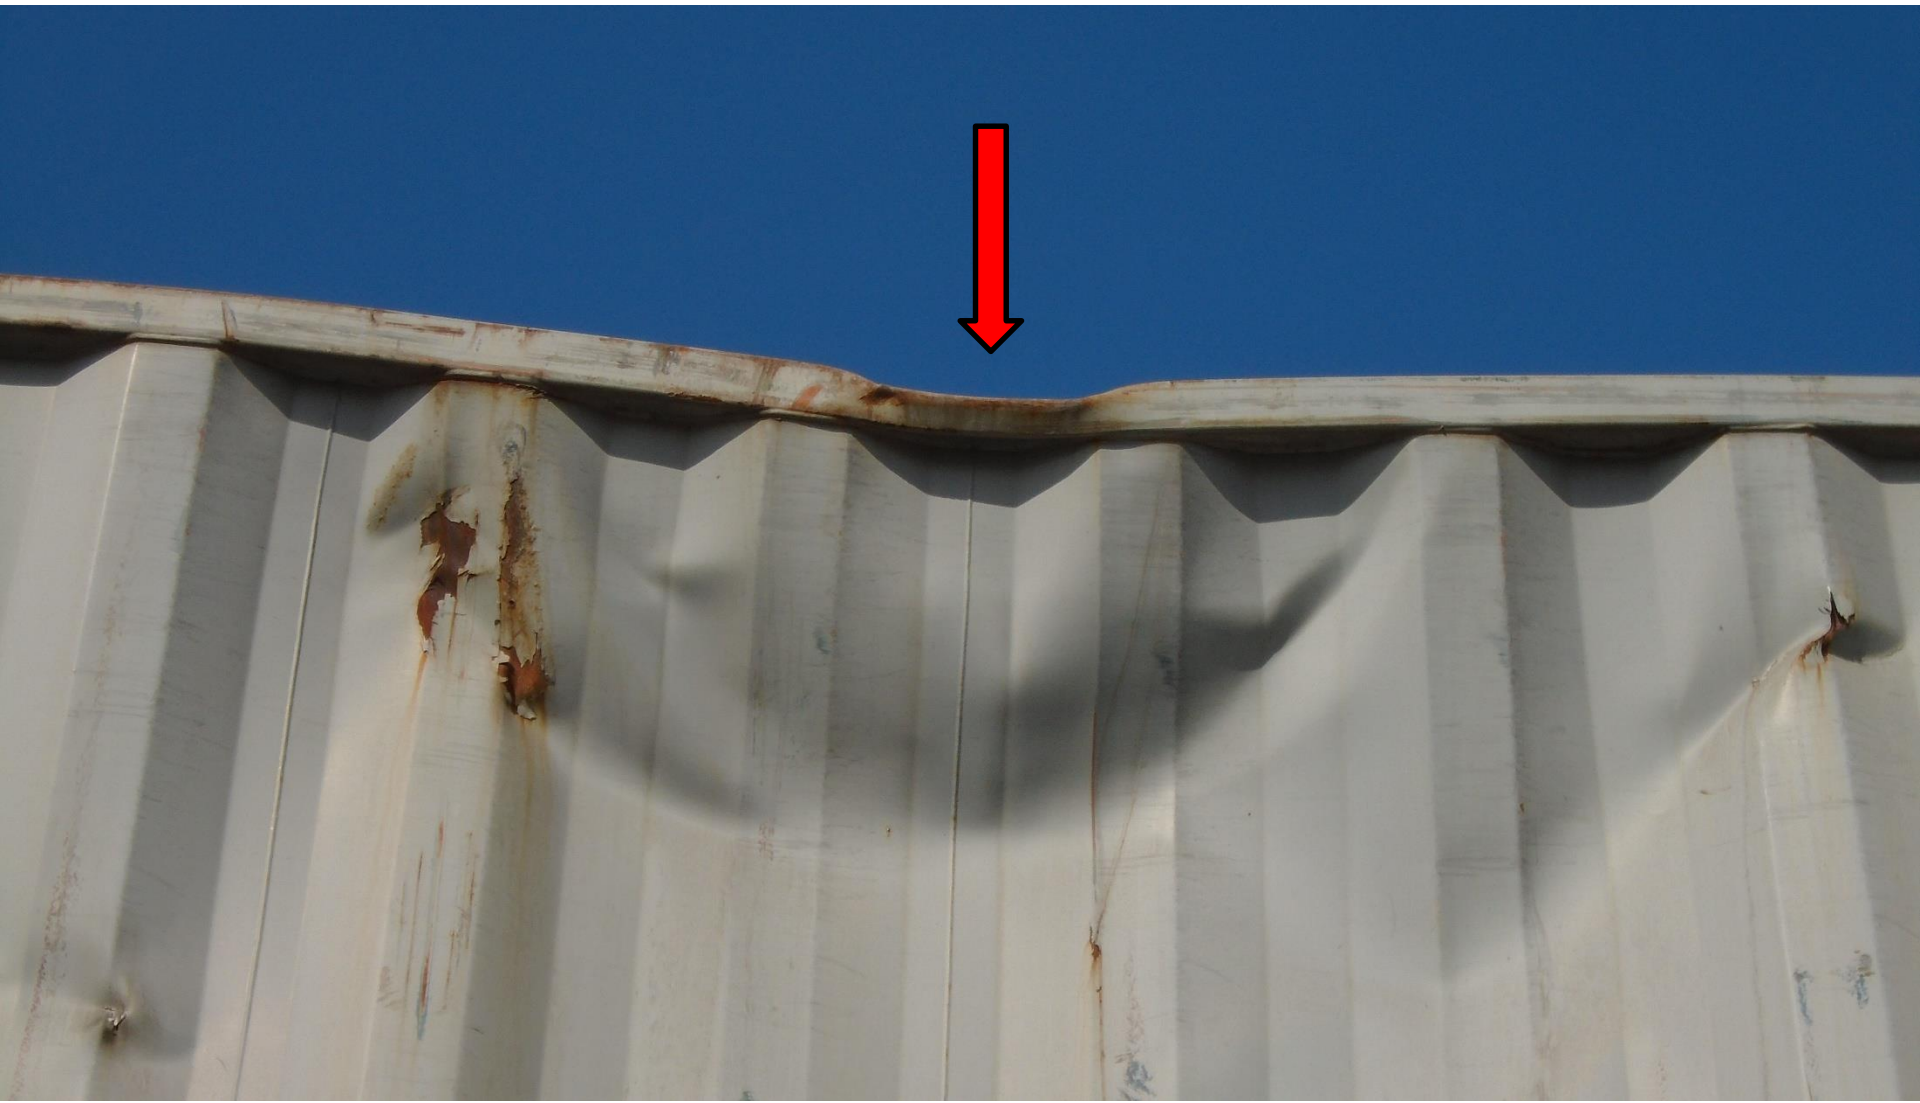
Push In/Dents @ top side panel

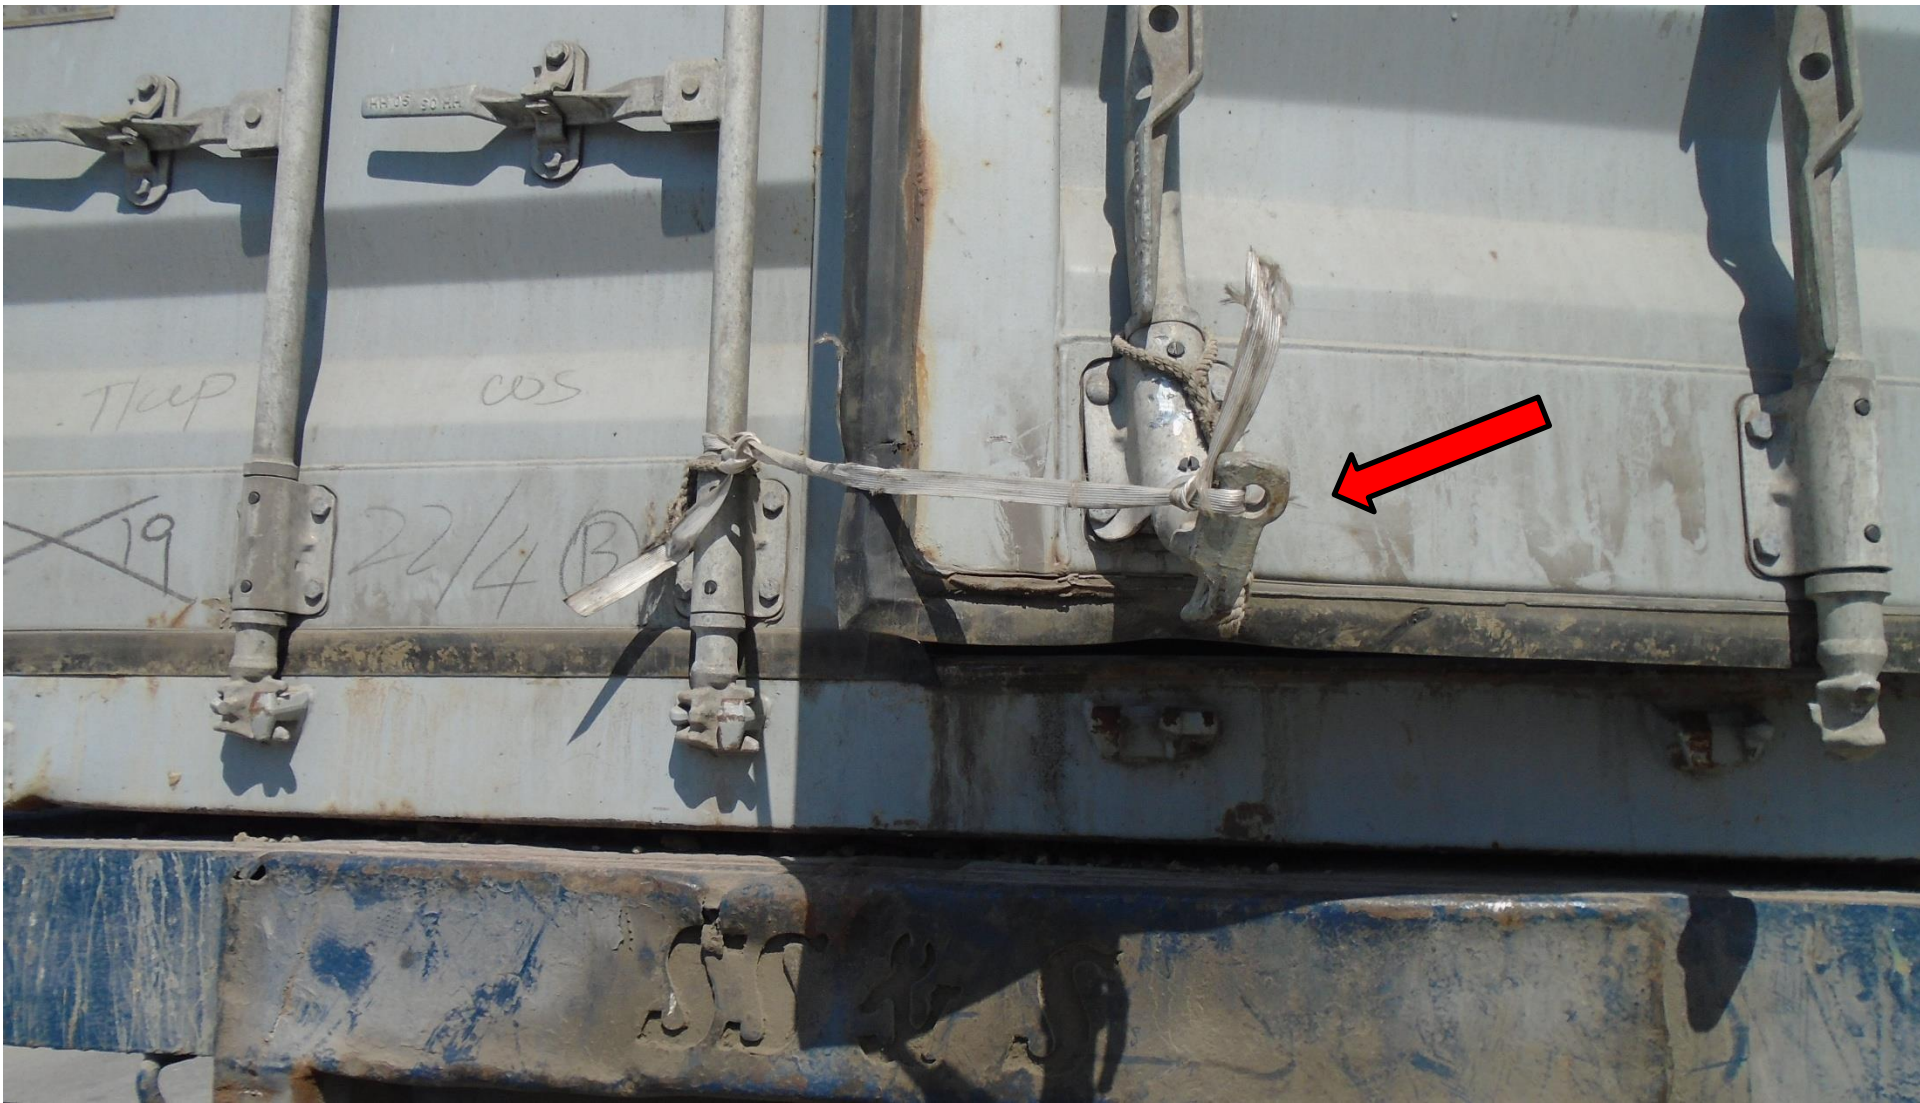
# Bent Cam Keeper (Major Damage)

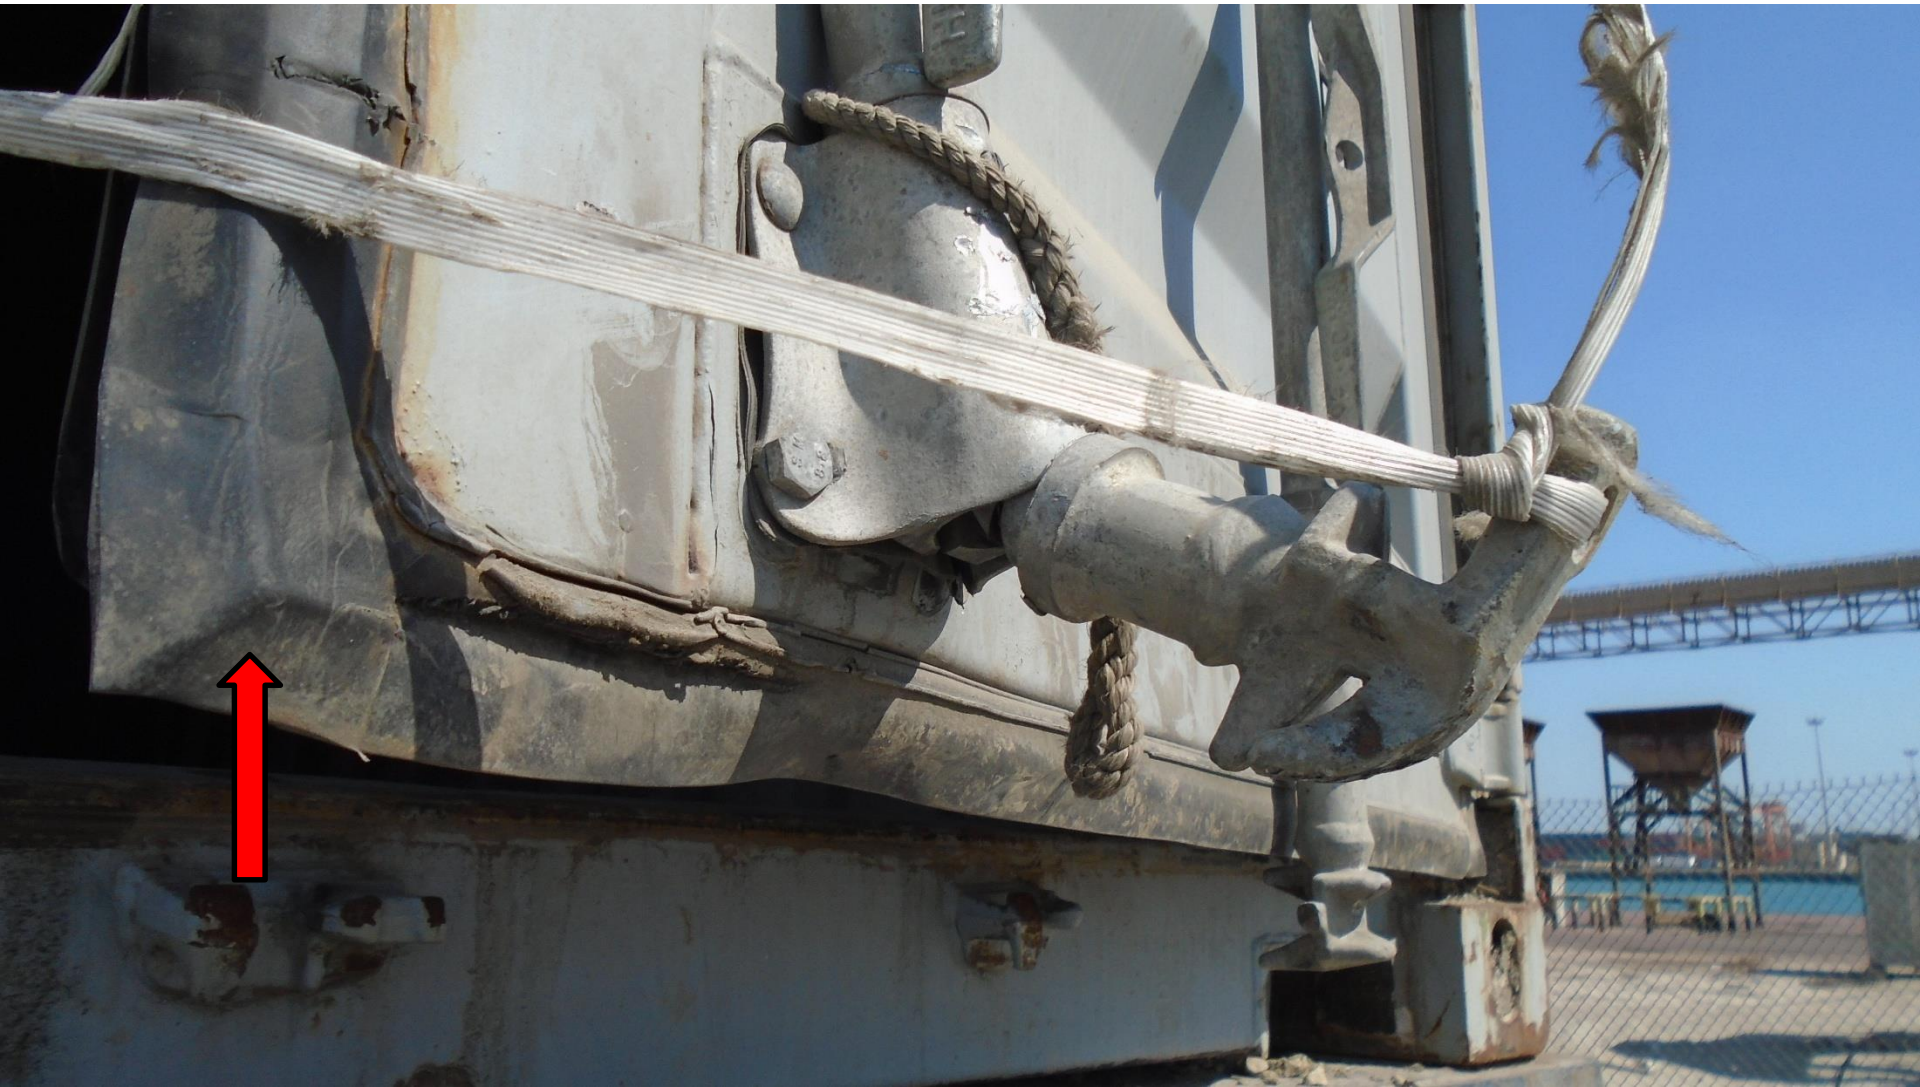
# Door Gasket (rubber gasket) (Major Damage)

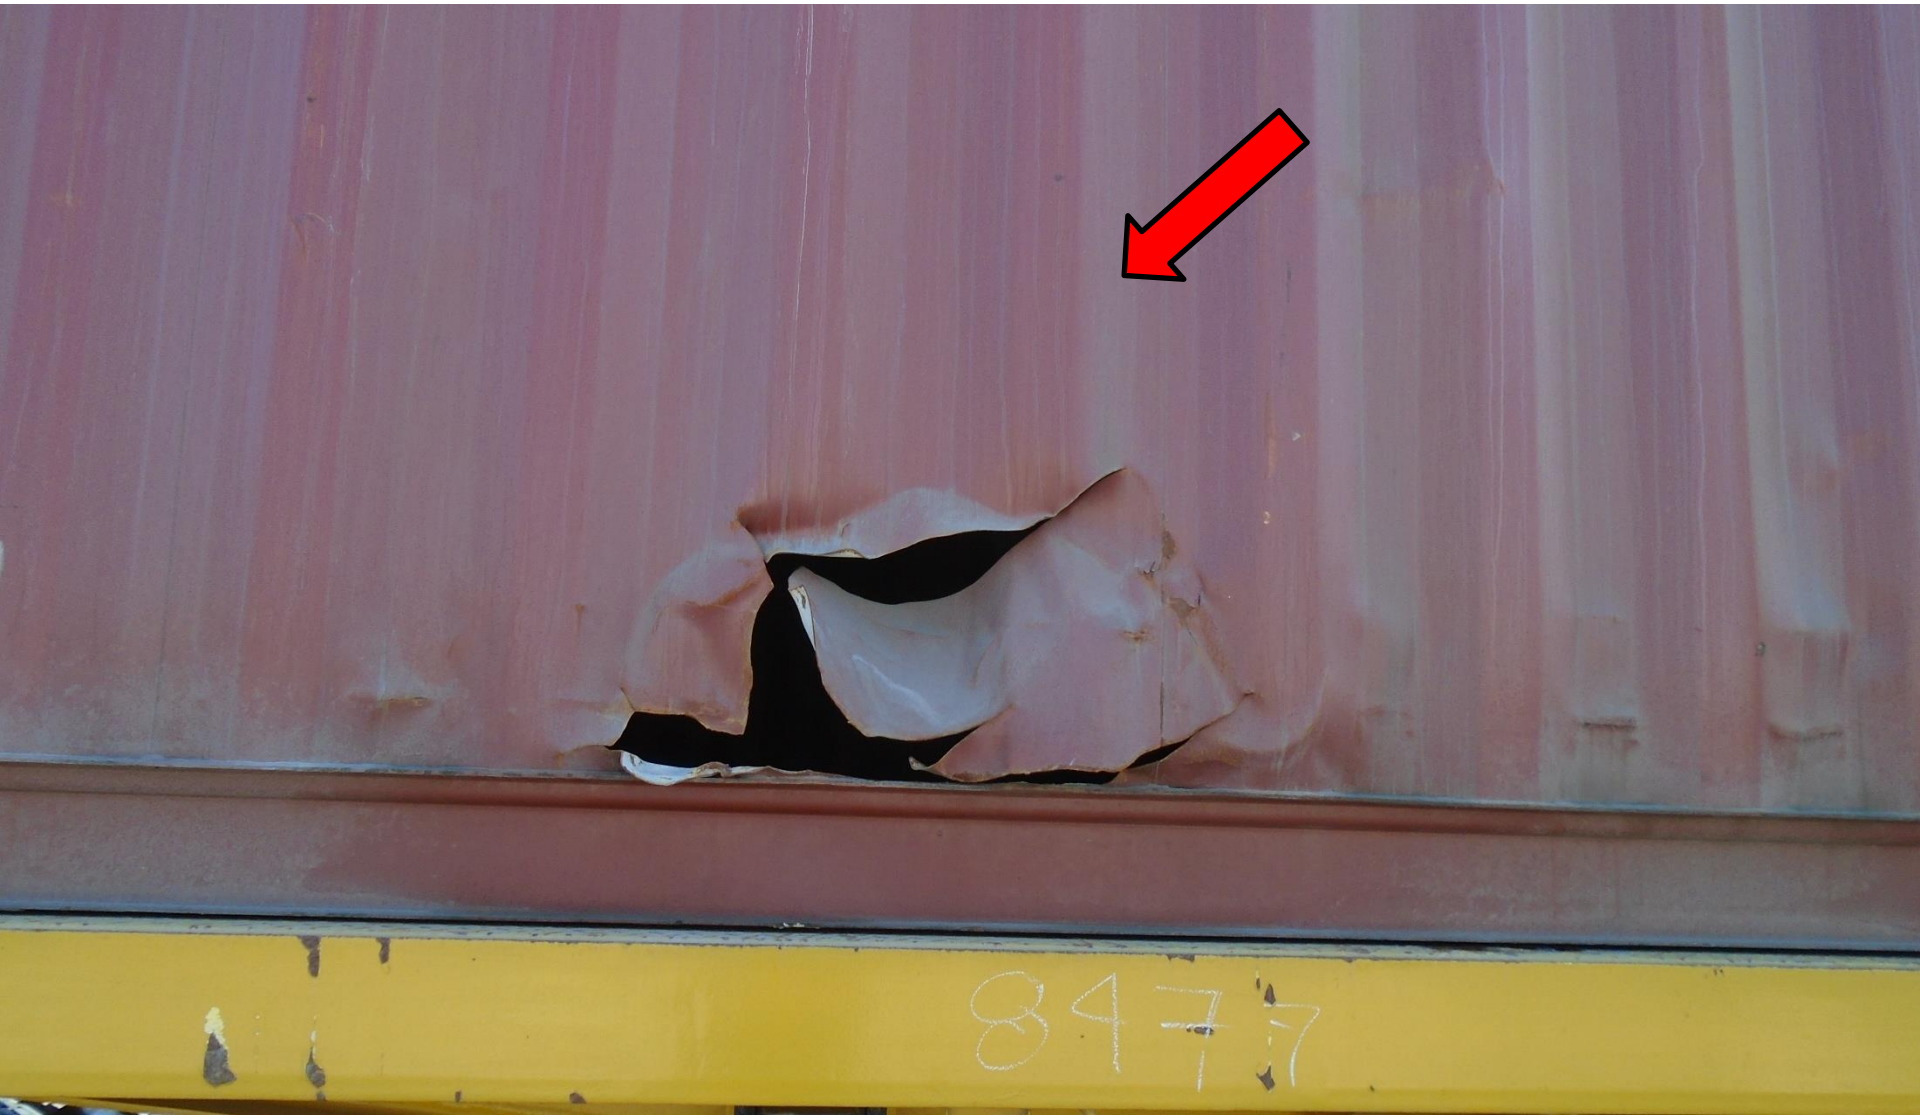
Big cut @ below side panel  
(Major Damage)
